River Otter Beaver Trial

Science and Evidence Report

The River Otter Beaver Trial is a 5-year trial reintroduction of Eurasian beavers, *Castor fiber*, into the wild in south east Devon. It began with two family groups of beavers in 2015 which have now bred and dispersed throughout the catchment. The Science and Evidence Forum have overseen a detailed research programme, the findings of which are summarised within this report.

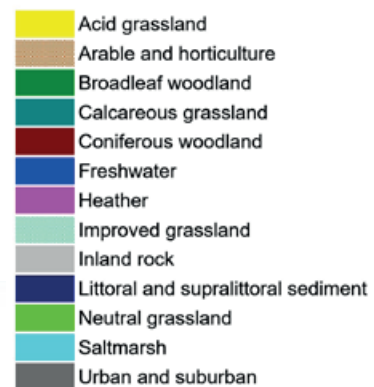
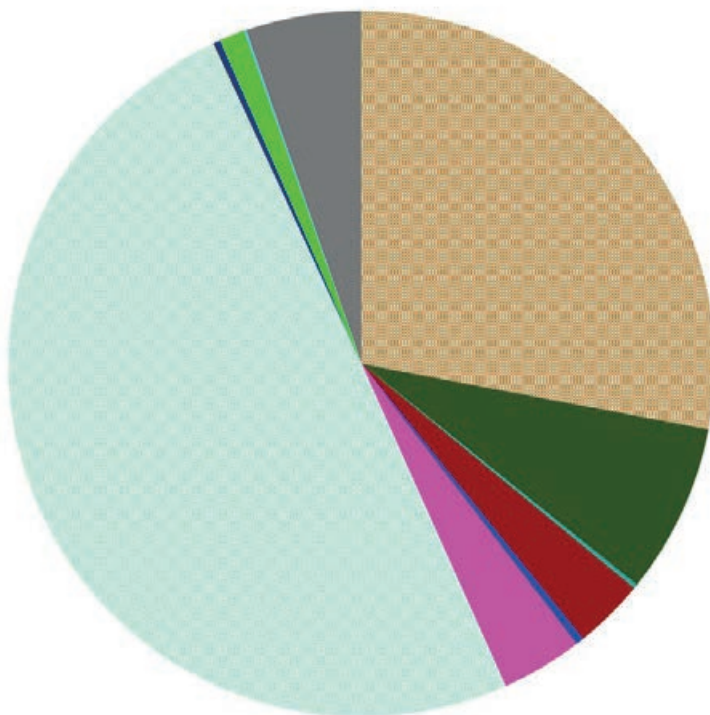
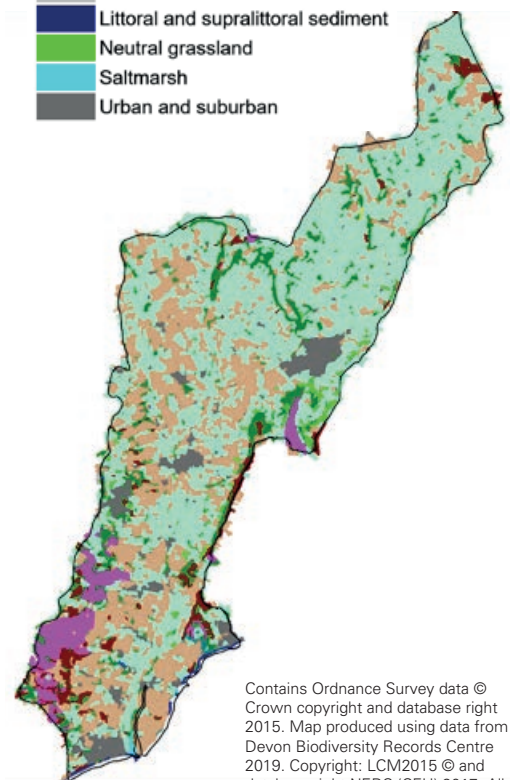
Figure 1.1 Land use in the River Otter Catchment

The catchment covers ca. 250 km² (25,010 ha). Land use composes: 50% improved grassland, 28% arable and horticulture and 5% urban and suburban. The remaining 17% is covered by woodland, other grasslands, heathland, freshwater, saltmarsh, littoral sediment, and supra-littoral sediment¹.

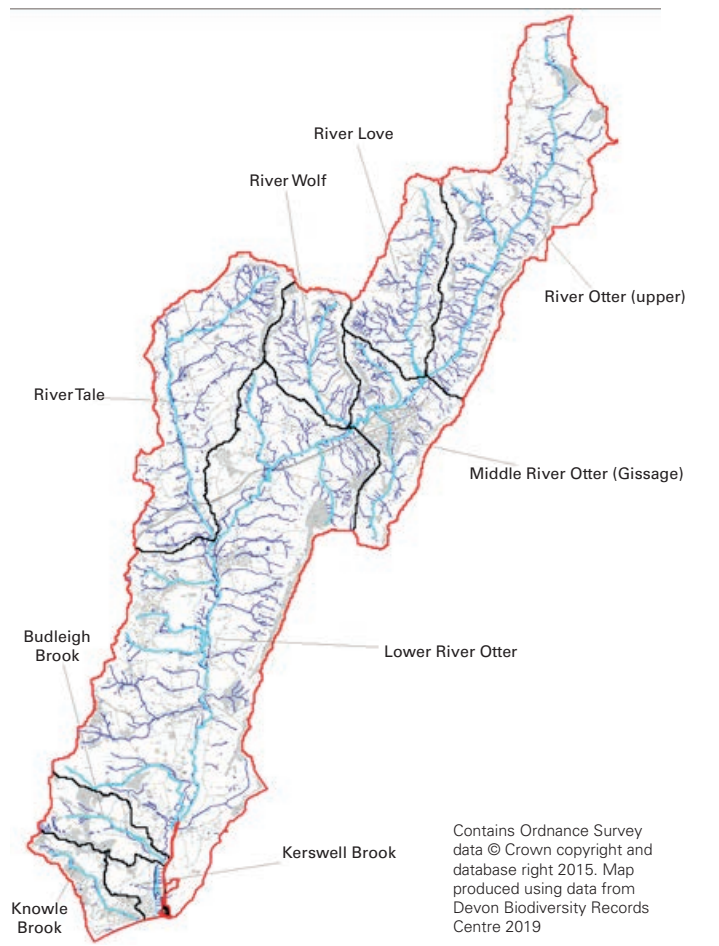
The River Otter is divided into nine sub-catchments, with the main tributaries being the River Tale, the River Love and the River Wolf all rising from the Upper Greensand scarp, along with the Upper Otter. The main stem of the river is in excess of 65 km in length between the Otterhead Lakes and the sea.

- River Otter Catchment
- River Otter & main tributaries
- Minor tributaries
- Sub catchments

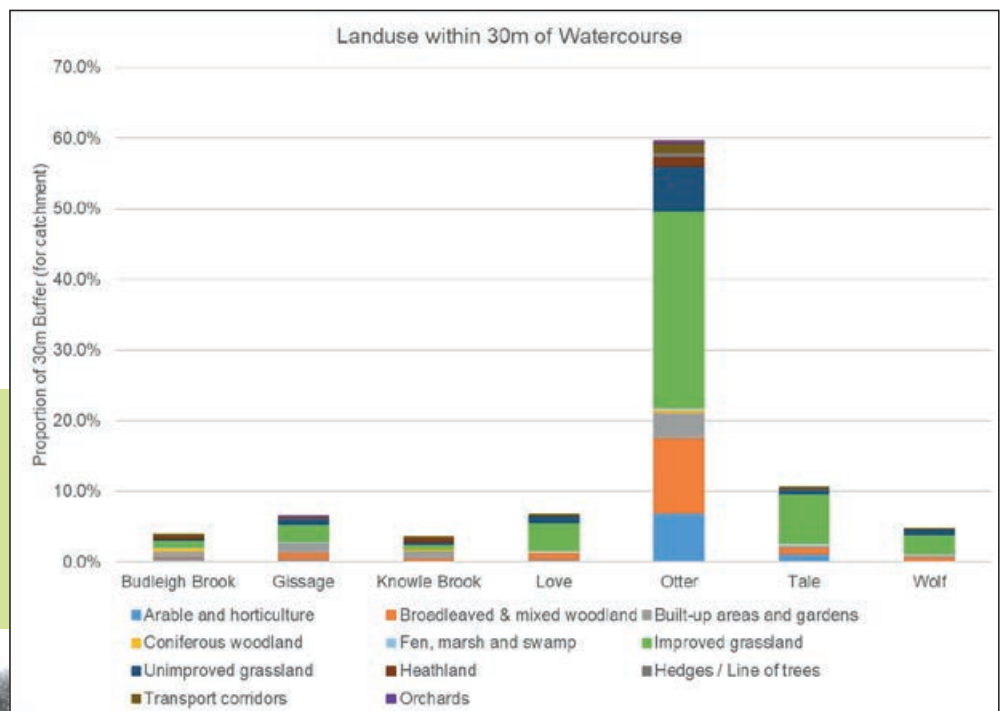
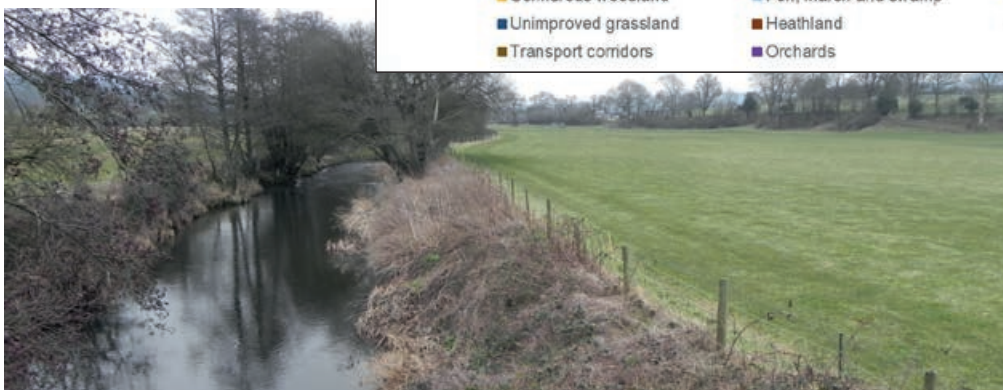
→ **Figure 1.3** Aerial Photographic Interpretation of the land-use within a 30 m buffer of all of the key watercourses within the catchment identifies the land-uses most likely to be affected by the activities of beavers. The total area of this buffer is 3,378 ha.

Survey work carried out during the Trial shows that 99.8% of feeding signs are detected within 30 m of the banks of watercourses (see figure 5.1).

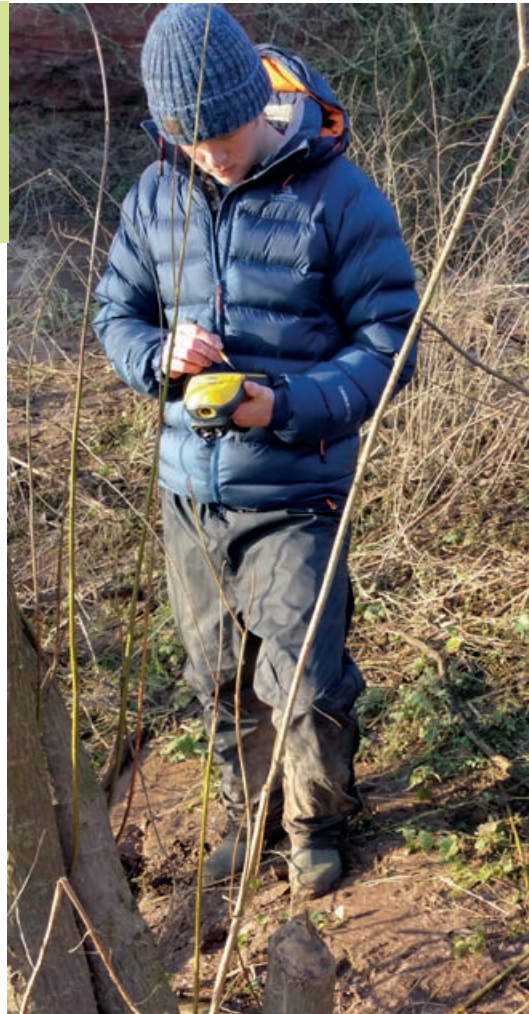
→ The ROBT team were able to increase the efficiency of survey work through the acquisition of a Trimble Geo7 GPS device that allowed the user to input data directly into a Geographical Information System (GIS).

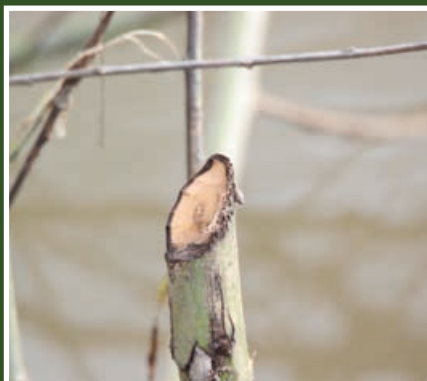
Figure 1.4 Browsing by beavers on trees was recorded into three impact classes using this classification

Low Impact – fewer than 20 cuts (branches or stems), all <7 cm in diameter, and / or stripped bark area <10 hands (ca. 0.2 m²).

These impacts are easily detectable during the winter months and provide the basis of the systematic surveys. Initially each cut stem was mapped, and details recorded. This soon became impractical, and so each tree impacted was mapped and classified as detailed in Figure 1.4 (above). This classification was designed to represent the time that the beavers had spent at the location, and also to reflect the societal impacts of this beaver behaviour. The species affected and the distances from the watercourse are detailed in Chapter 6.

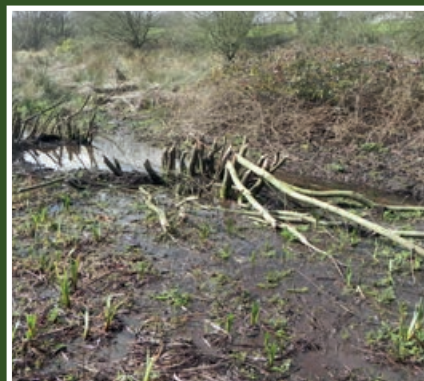
Medium Impact – greater than 20 cuts (branches or stems), or with at least one >7 cm in diameter, and / or a stripped bark area >10 hands (ca. 0.2 m²).

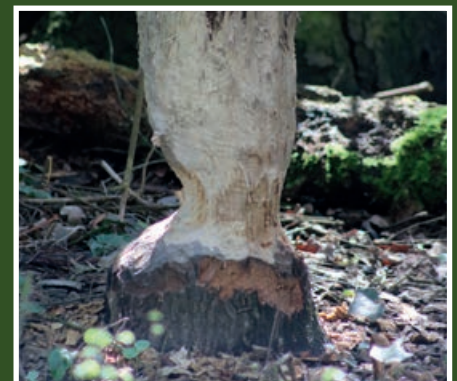
Major Impact – Tree / main stem with a diameter >20 cm, either felled or noticeably incised (i.e. beyond the cambium and noticeably into the sapwood, and not simply bark stripped).

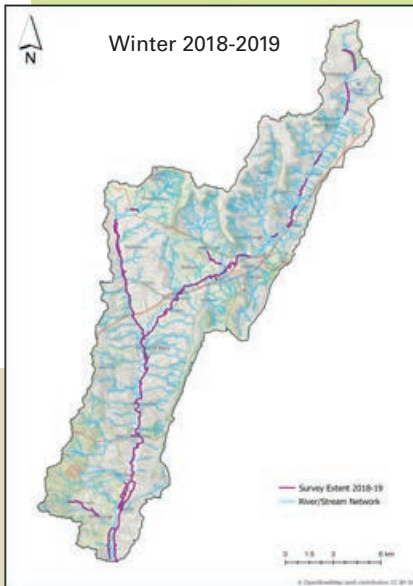
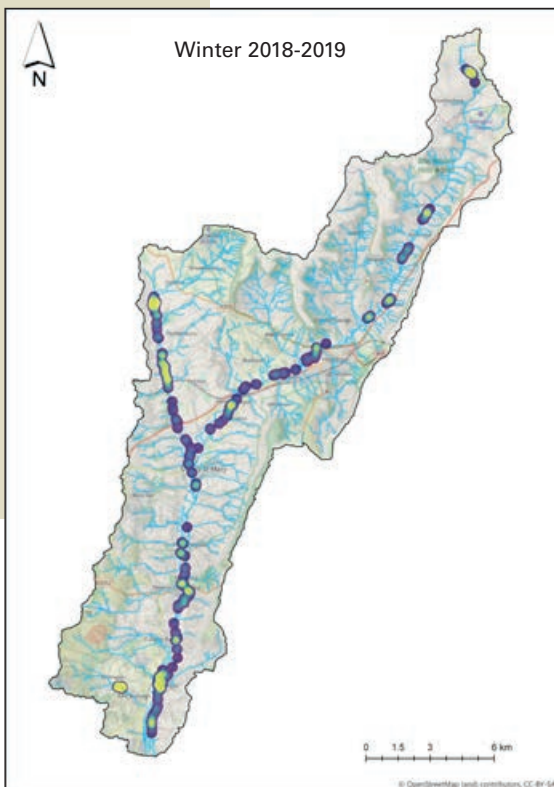
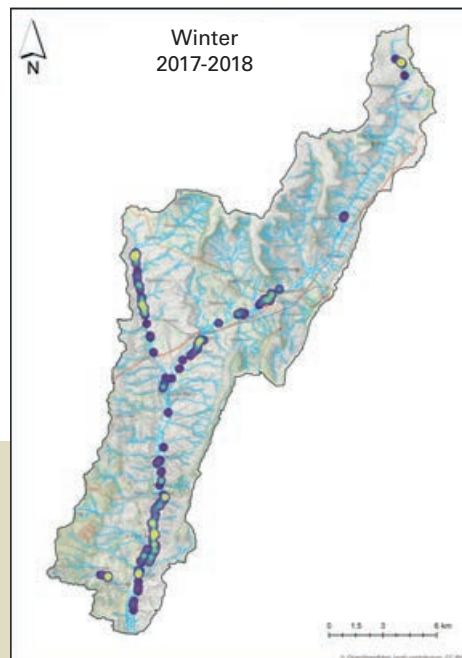
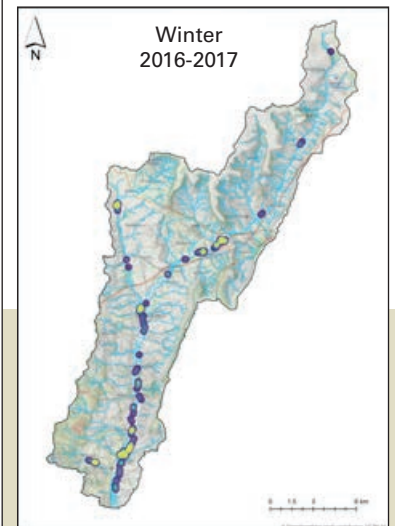
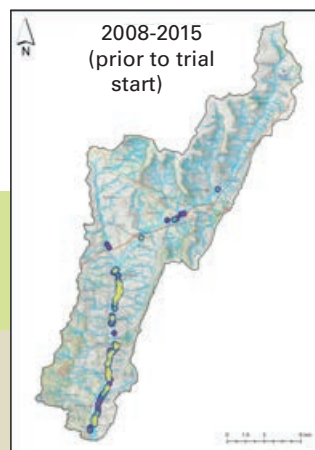
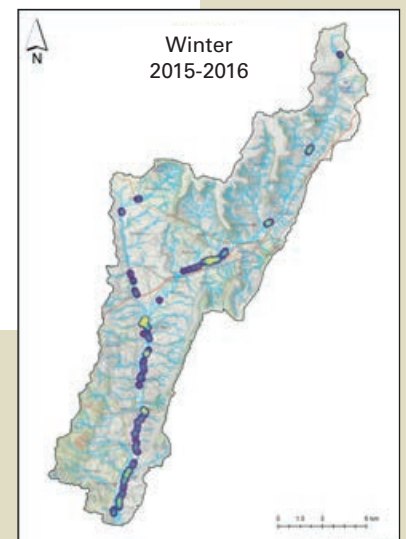
→ **Figure 1.5** Heat maps produced at the end of each survey season in March provide a useful snapshot of feeding signs throughout the catchment.

← In the winter 2015-16 survey, data were also collected on older field signs to understand the historic (pre-Trial) distribution. Some field signs clearly pre-dated the start of the Trial and can be aged using regrowth, but for many, it was much harder to determine, and the dataset (heat map) for pre-trial should be interpreted with a larger margin of error.

Beavers are 'central place' foragers⁴ and therefore the frequency of feeding signs declines with increasing distance from a dwelling. This pattern is reflected in the heat maps presented in Figure 1.5. However, the key limitation of the feeding sign survey is that it identifies beaver presence only where woody material is also present. Therefore, in reaches where woody habitat is discontinuous, feeding density is similarly discontinuous. In these reaches it becomes difficult to differentiate between multiple small territories and fewer larger territories^{2,3}.

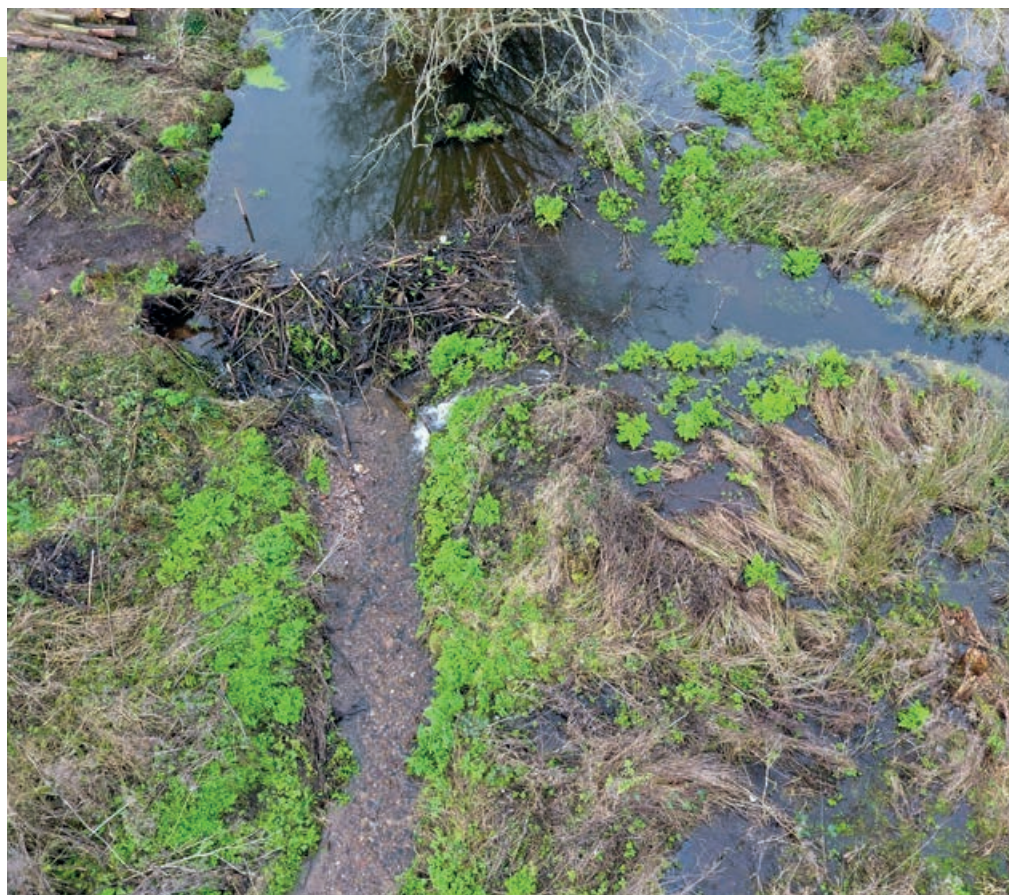
→ A beaver-created wetland
in the Budleigh Brook

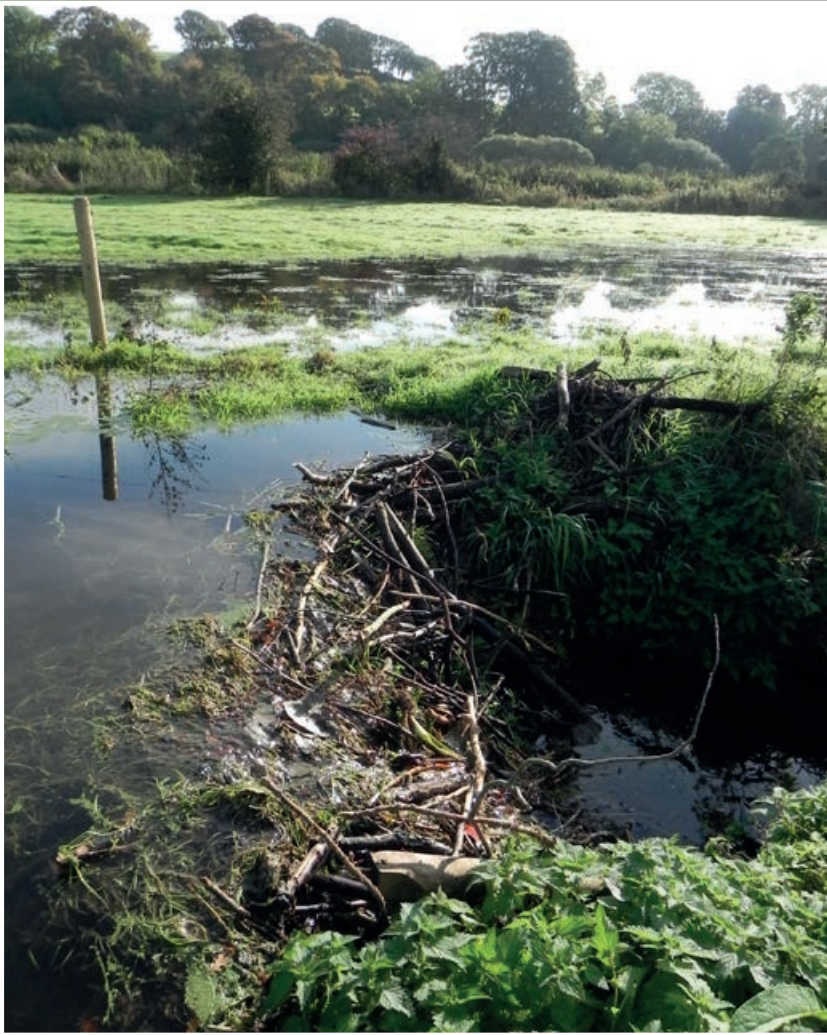
← **Colaton Raleigh stream** is a groundwater fed watercourse that originates on Colaton Raleigh Common. The watercourse has been heavily modified by land drainage and runs in a ditch network through floodplain pastures before joining the main River Otter in Otterton. Within this network, beaver dams have been built in 13 locations since September 2016. This is a low gradient drainage system and although high flows and human intervention have regularly changed the dam heights, a few have been washed out in their entirety. Three of the smaller dams have also been drowned out by other dams built downstream of them.

The creation of wetland habitats has been rapid and the management of three dams has been necessary to mitigate impacts on land-drainage / raised water level, including the installation of a flow device (aka a 'beaver deceiver') which is detailed in **Case Study 1**.

In October 2019, eight dams were present and due to the flat nature of the topography, 813 m of the ditch network were impounded by them.

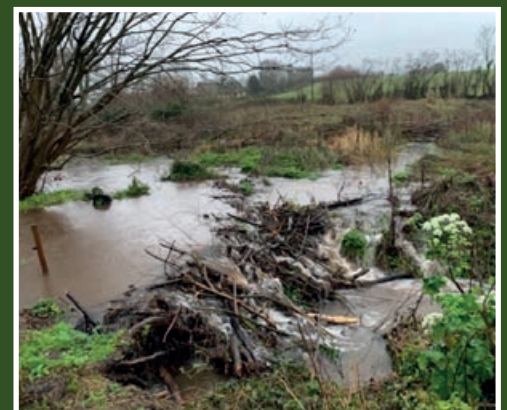
↑ The **Budleigh Brook** rises on Bicton Common before passing through Yettington and East Budleigh. Six dams have been constructed in the channel and two of these have pushed water out of bank, with retaining bunds also built by the beavers on the adjacent floodplain.

These six dams have impounded 292m of the original watercourse and created 0.1ha of open water, in addition to other wetland habitats around the standing water.

At this location the creation of the wetland has been supported by the landowner, and is the subject of research into the beneficial impacts on flood risk in a community downstream (see **Case Study 2**). Impacts on agricultural activities have also been quantified.

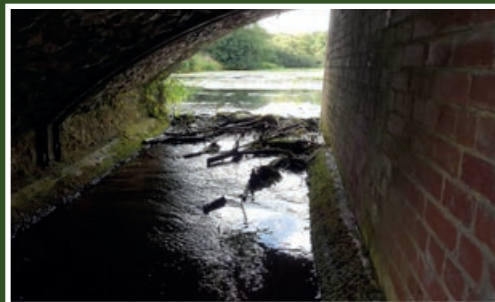
→ **Otterhead Lakes**. Dams have been built in seven locations upstream of the top lake/reservoir, although these are dynamic features due to high flows. In total 11 dams were recorded in various watercourses in this complex in October 2019. Owing to the steeper gradient here, they impounded only 246 m of watercourse (which includes the main lake with slightly elevated water levels at this time).

The beavers are continuing to build a small dam on the outfall structure to the upper lake, and this is removed regularly by volunteers on the site. Beaver dams have also been built in the overflow channel from the top lake. One was around the outfall structure which was removed, and others have been retained.

The potential implications on the water resources and supply infrastructure are discussed in **Case Study 4**.

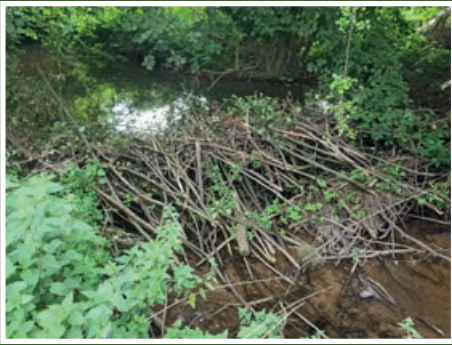
← The **Clyst William Cross (upper Tale)** site, where additional beavers were released (to improve genetic diversity) in 2016, is where the largest number of dams have been built. In the main River Tale, dams have been built in eight different locations. The high-energy nature of this watercourse has made these dams very dynamic, often ephemeral, features. It is estimated that a total of 22 individual dams were built in eight locations on this reach of the Upper Tale over the 4 year period since 2016. Only one was in place in October 2019; a large 1.8 m high dam structure, which was impounding 208m of the stream and was bypassed by side channels cutting across the river floodplain.

Nine dams have also been built in the adjacent wetland habitat away from the main stream, including in new channels also created by the beavers, and not including the retaining earth bunds built to retain water in flat low-lying land. (see **Case Study 5**).

At Clyst William Cross, beavers have constructed several dams within the main channel of the River Tale (**see Case Study 5**). At this location, the River Tale is an incised 4th order stream with relatively large high-flow stream power. (Stream order describes the size of river and is based on the number and size of contributing tributaries; at its mouth the River Otter is 6th order). Consequently, the dams in this reach are regularly breached during periods of high flow and repaired by beavers during lower flows. The release of impounded water during a dam breach has resulted in the localised erosion of riverbanks immediately downstream of the dams. Consequently, there has been visible change with increased bankfull width and sinuosity, with sediment and gravels re-deposited creating a more mixed channel bed surface than before both upstream and downstream of the dams.

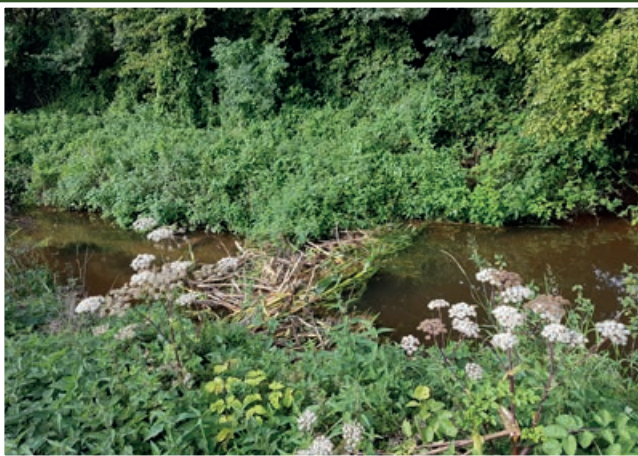
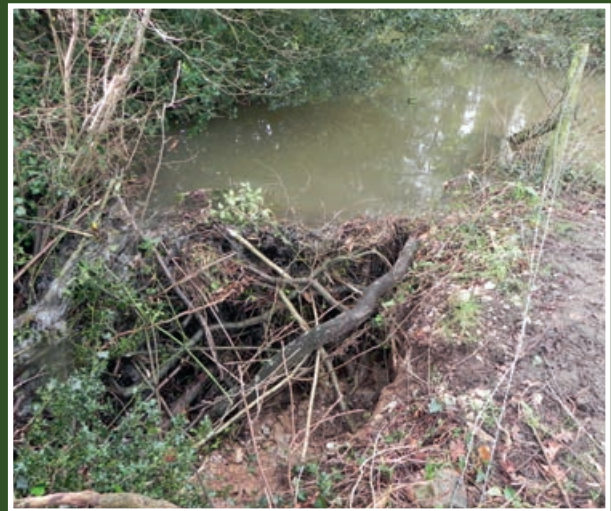
↓ In the **mid-River Tale**, dams have been built in four locations, often during low summer flows to access adjacent food resources (maize). At two of these sites, dams were unacceptable to some, but not all, of the landowners, and any signs of beavers starting to rebuild the dam were repeatedly removed by ROBT staff; in one case on 10 occasions over a period of three weeks. High flows commonly erode these dams and going into autumn 2019 only one 0.6 m high dam was in place. **Case Study 6** discusses the conflicts with land drainage, and associated issues between neighbours in this flat landscape.

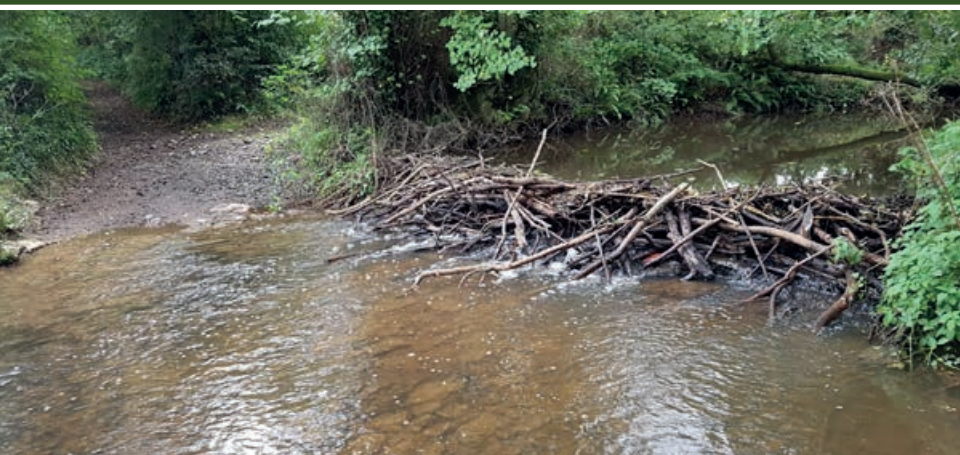
↑ The **Cadhay stream** near Ottery St Mary was the location for the first beaver dams in the catchment. In early 2016, a 0.8 m high dam was built in a drainage ditch impounding water in low-lying pasture where a flood relief channel discharges peak-flows. This was initially removed by the landowner because of the impacts on land-drainage, and then again twice subsequently by ROBT staff. Two other smaller dams were also removed in the same ditch to prevent them becoming established. They have not been rebuilt since.

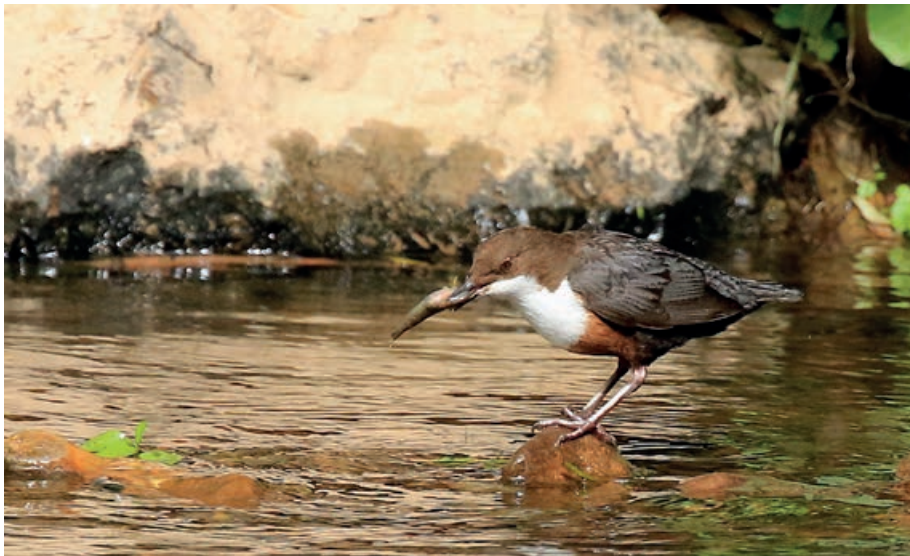
↑ The increased channel heterogeneity created by beaver dams, creates new riffle habitat for dippers and bullhead.

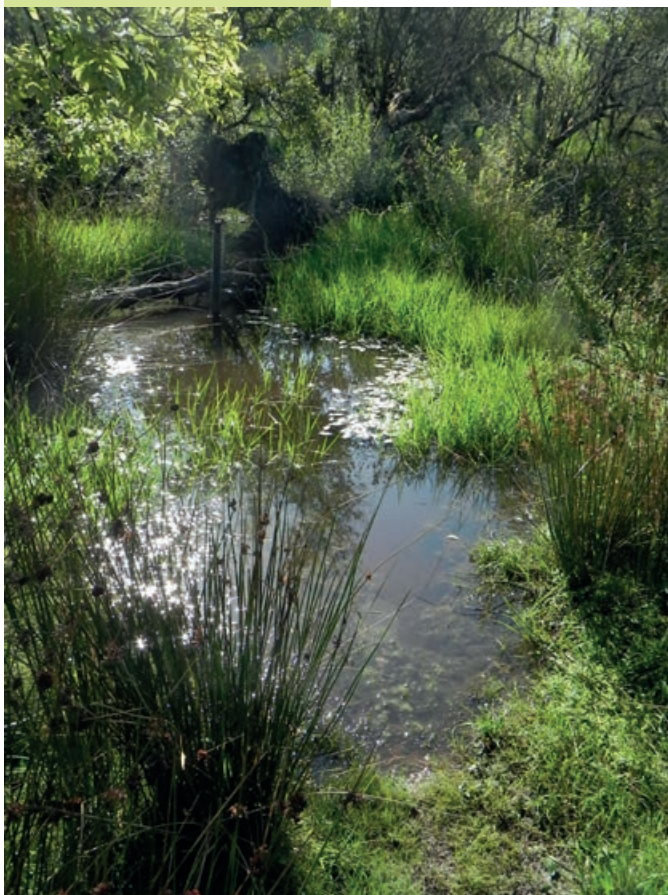
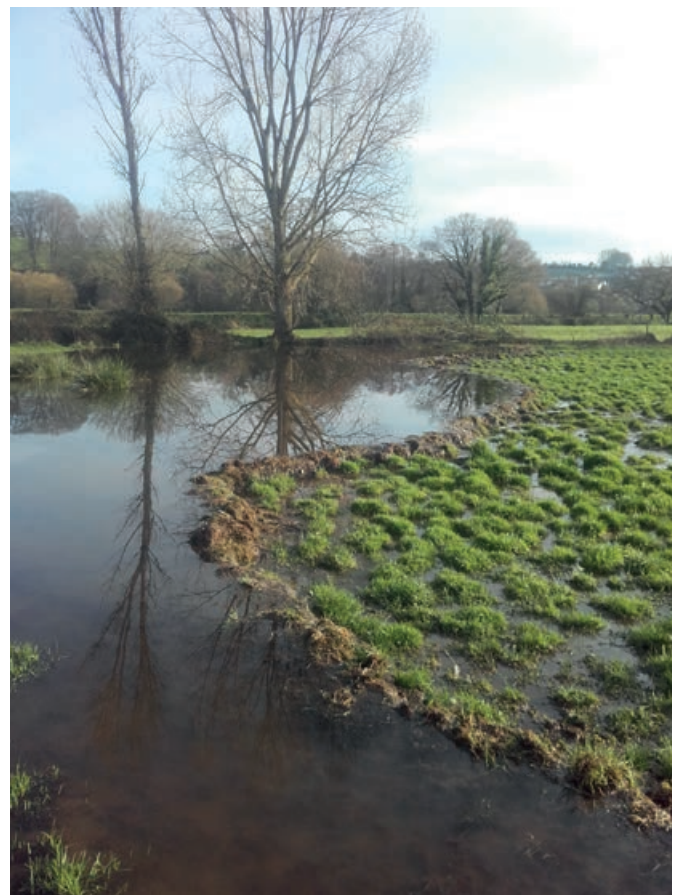
↓ Beaver dams create a mosaic of wetland habitats which benefit a wide range of wetland species.

↑ Wetland habitats formed where water spills over and around a beaver dam often support important emergent vegetation communities.

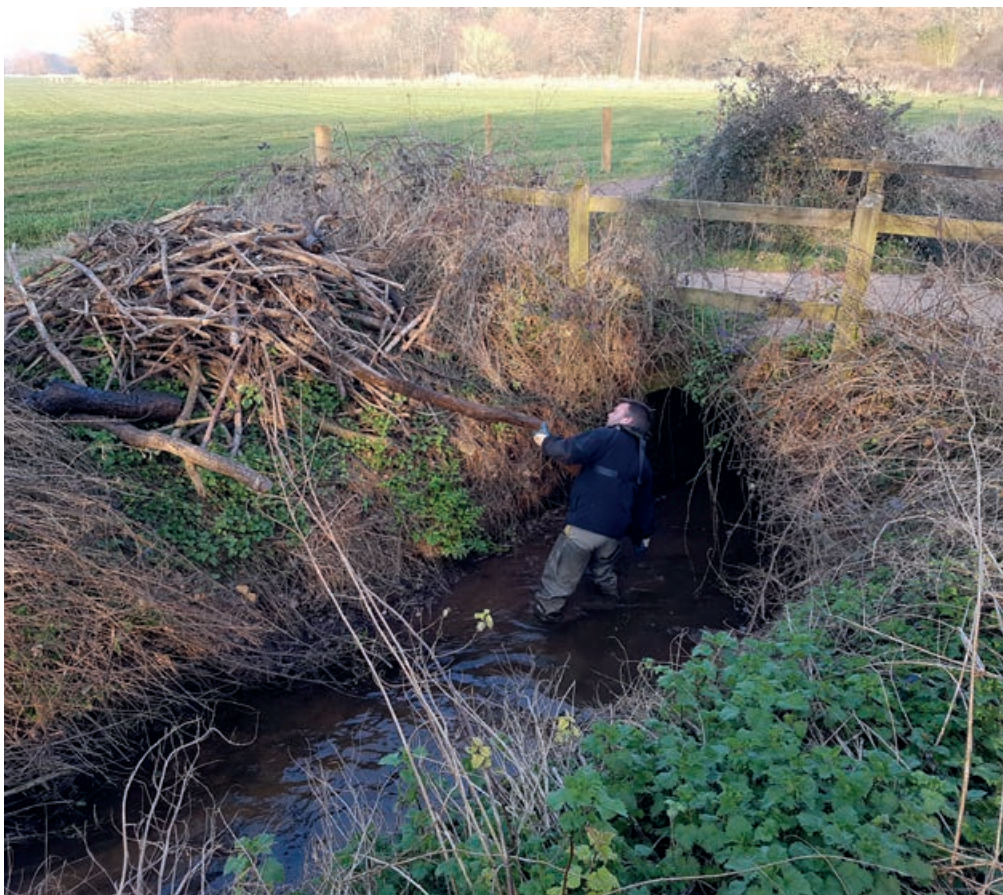
← ROBT Staff clearing a blocked culvert

Within the Colaton Raleigh stream, the beavers have used the constricted channel provided by two culverts to attempt to impound water. A small number of beaver sticks have been removed occasionally from one of these culverts. The other culvert has required more frequent monitoring and intervention, as a result of a more concerted attempt by beavers to block it. This management regime remains effective.

Elsewhere beaver activity was thought to be the reason for a blocked culvert, but on closer inspection this was shown to be flood debris which was removed by the ROBT team.

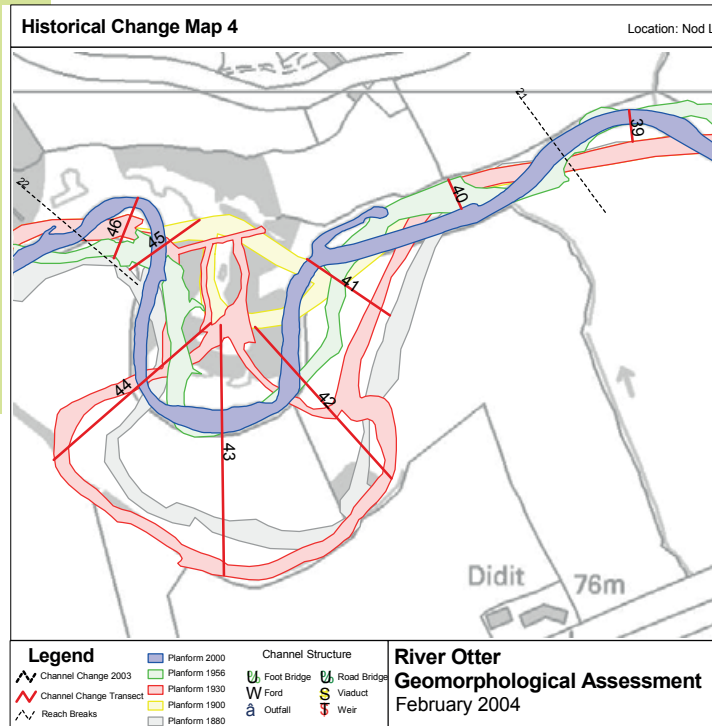
→ Figure 1.6

A Geomorphological Assessment of the River Otter includes detailed maps showing changes in planform that have occurred since 1880. (Copyright Environment Agency). This section near Honiton demonstrates clearly the high background rates of change that have occurred in parts of the valley since 1880.

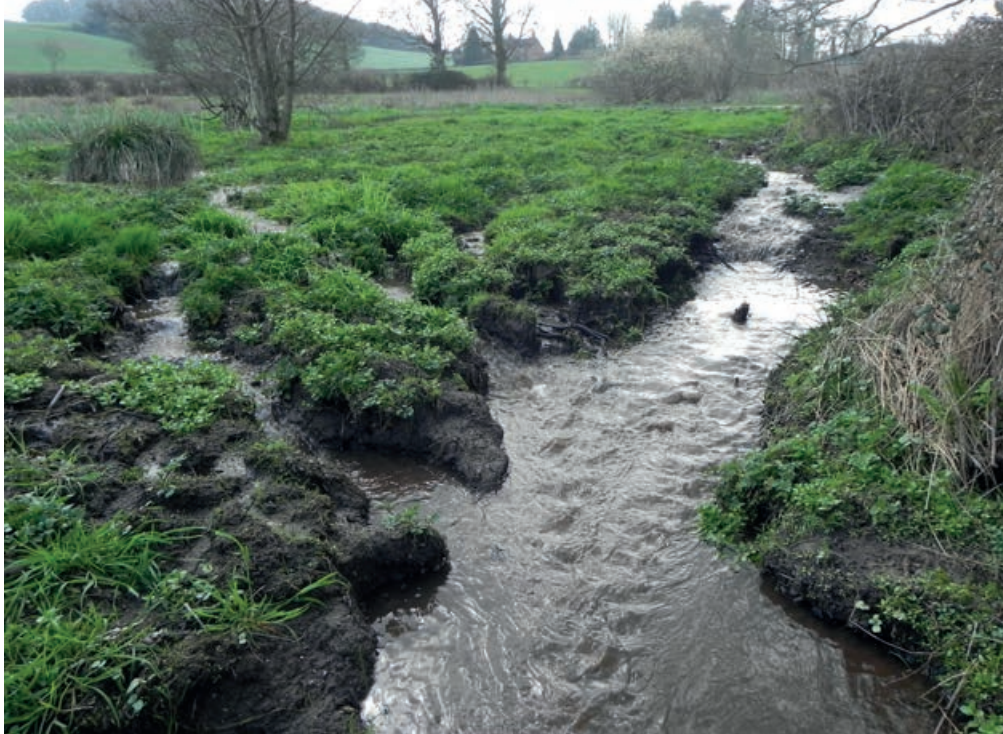
← An avulsion (channel rerouting) event has been observed on the Budleigh Brook where a beaver dam originally built in the stream, now extends across the floodplain. The new network of multi-thread channels has begun to incise, revealing rounded pebbles and cobbles, indicative of previous channel beds, deposited before the channel was artificially straightened and deepened.

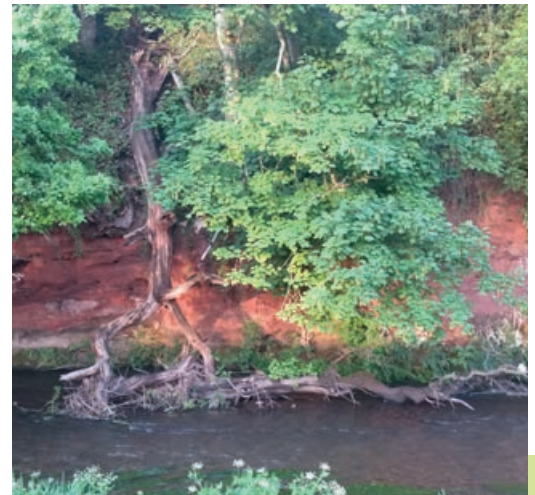
↑ The proportion of in-channel woody material derived from other sources has not been assessed. During the Trial a number of larger trees have been observed entering the channel as a result of bank erosion or storm events, rather than beaver activity, particularly in the area downstream of Ottery St Mary.

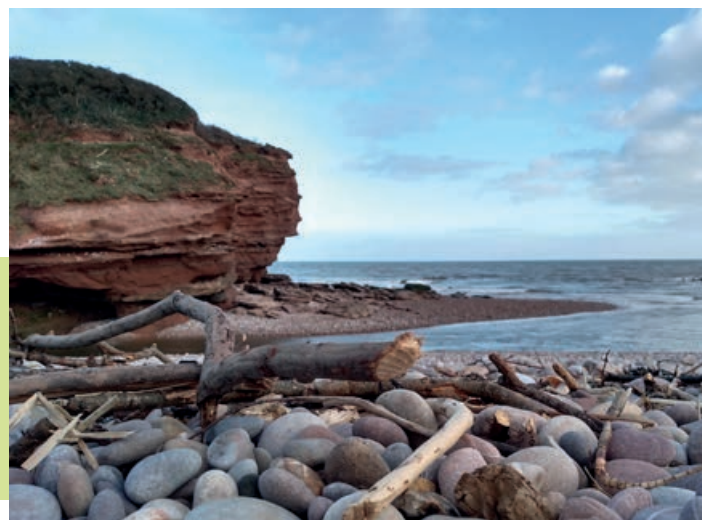
→ The presence of beaver sticks is a useful way of confirming the presence of beavers upstream. Beaver sticks have been seen in the strand-line on the beach at the mouth of the River Otter, one of many 'firsts' in England for some hundreds of years.

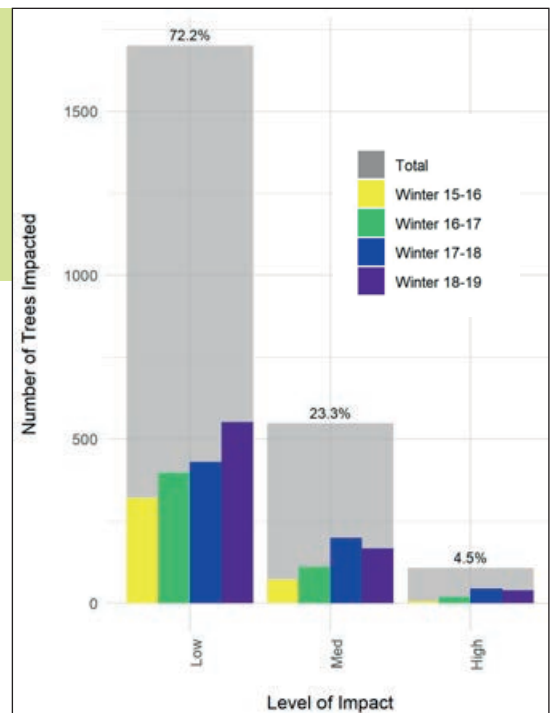
→ **Figure 1.7** The majority of trees were only subject to low levels of feeding. The number of trees impacted increases as the population expands. Although surveys were conducted annually, annual counts cannot simply be added as the same trees are often browsed over multiple years.

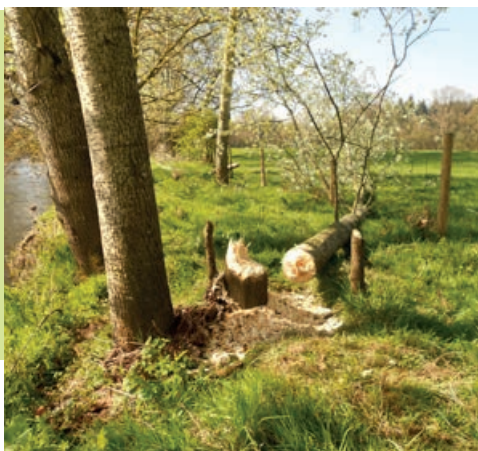
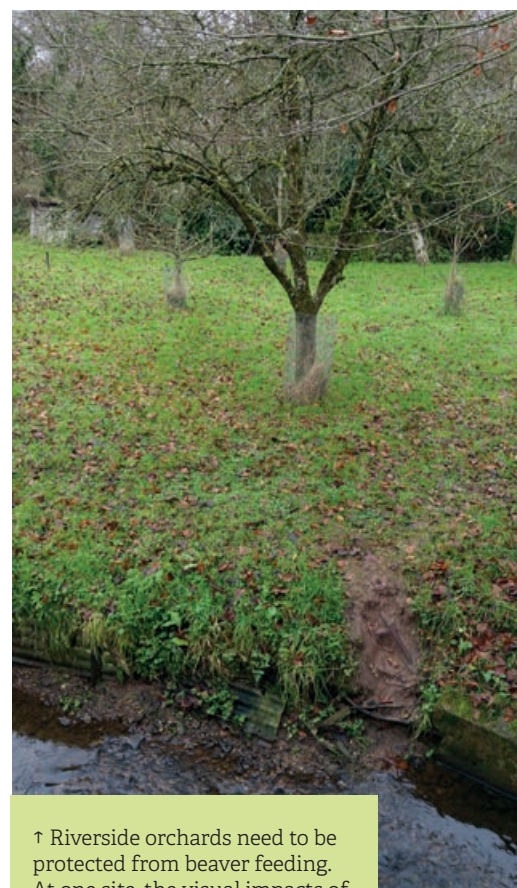
→ In one site, a strip of willow and poplar trees, originally planted for bankside protection, were subject to regular beaver feeding. In these situations, rotational coppicing of trees might sometimes be used to reduce canopy height and help stabilise the bank. The beavers were providing this coppicing effect, although the landowner was concerned about some of the larger trees and so these were protected.

↑ Riverside orchards need to be protected from beaver feeding. At one site, the visual impacts of the tree guards remain a concern for the landowner, as does the fact that the beavers are taking the fallen apples before they are collected.

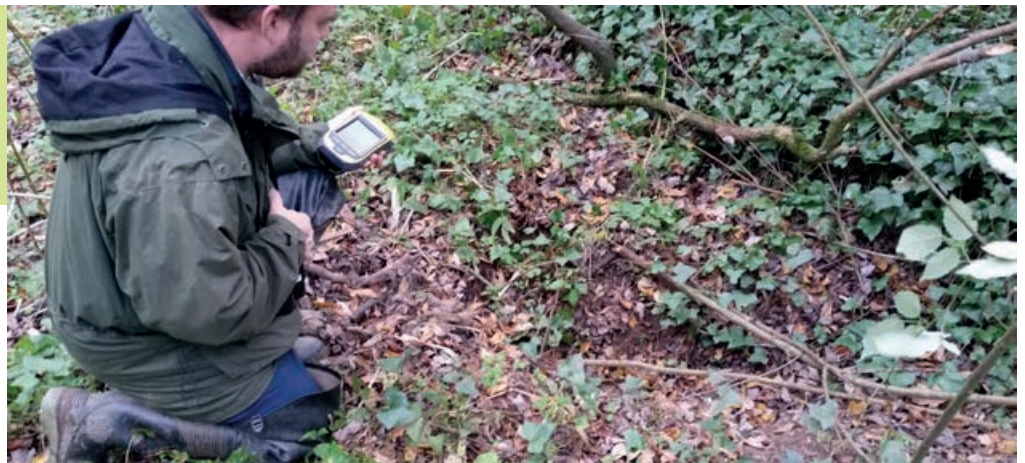
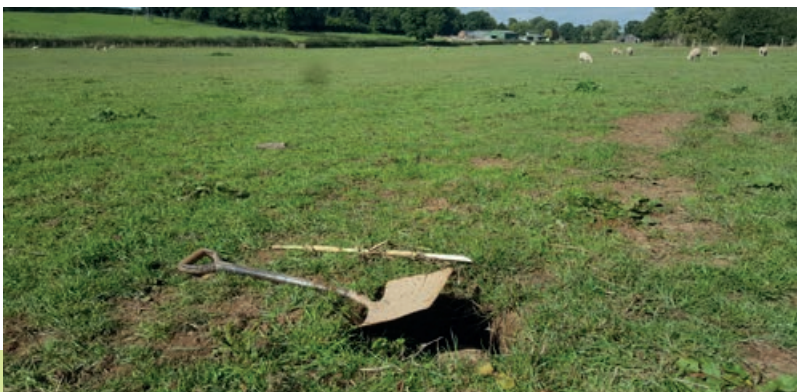
→ Most burrows have been detected in semi-natural strips of bankside vegetation where they go unnoticed by land-users and had no detrimental impacts.

↑ Conflicts have arisen on one site where land is grazed close to the riverbank. Two burrows have collapsed where cattle and sheep are present, and these required back-filling by the ROBT Field Officer. This conflict could be mitigated by providing a riparian buffer strip with restricted livestock access.

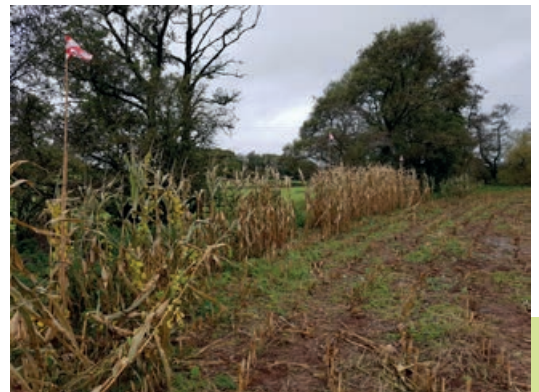
↑ To alert the operators of heavy machinery, flags were installed at one site when they were harvesting maize.

On the opposite bank where the maize field was due to be harvested, there was a risk of forage harvesters causing burrow collapses, and damage to farm machinery. To keep harvesting machinery away from potential burrows, bamboo canes with flags attached were placed at 10 m intervals along a 50 m strip. The flags were clearly visible above the maize, mitigating the risk of damage to farm machinery. The standardized approach for the assessment of costs based on data from the *John Nix Pocketbook*¹⁶ (see below) can be used to estimate the gross margin loss of leaving an unharvested strip against the watercourse. In this case a 5 m strip along 50 m of watercourse (0.025 ha) is estimated to be worth £22.10 for one harvest.

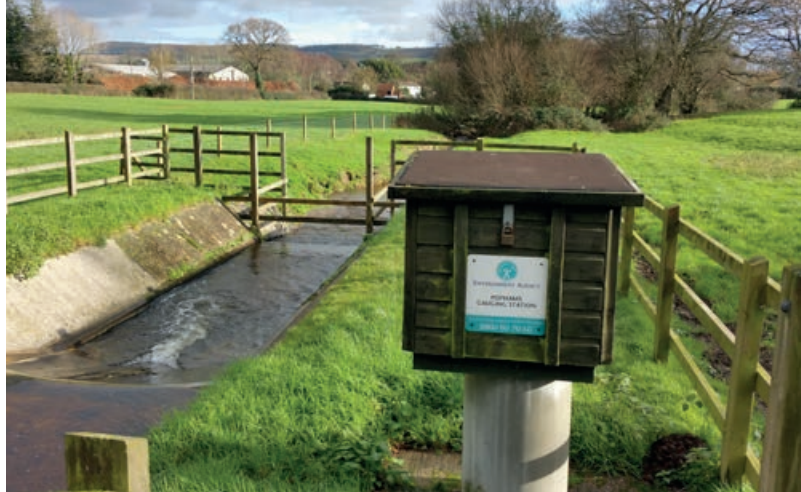
↑ Environment Agency monitoring equipment is routinely surveyed - no beaver impacts have been recorded in any of the infrastructure throughout the River Otter catchment.

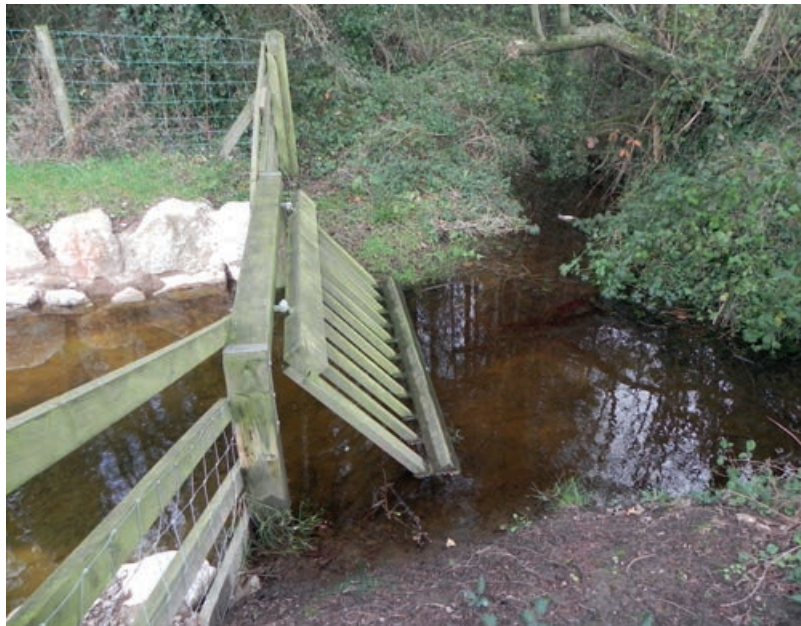
↑ In 2016, a beaver dam built in the floodplain ditch network into which a flood-relief channel discharges, resulted in standing water at the bottom of the scheme on the adjacent floodplain pasture. The farmer and ROBT staff removed this dam.

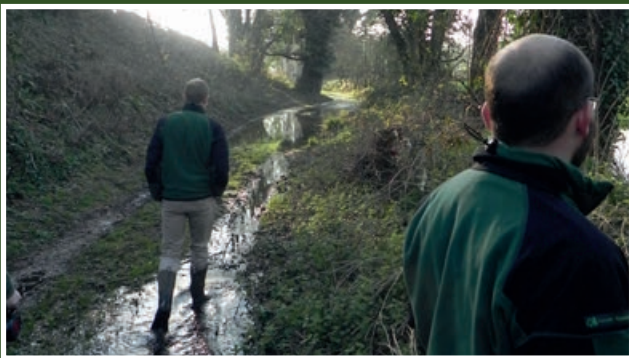
↑ Other access routes

One farm access track used by local residents as a permissive path to avoid walking on the road has been flooded to a maximum depth of 30 cm on occasions during the winter of 2018/19. This was due to the height of a beaver dam in a heavily modified watercourse, within a floodplain. The presence of the beavers and dam was being accepted by the landowners, but when this track became waterlogged, the dam was managed to bring the water-level down by up to ca. 50 cm. This same dam was submerging the corner of a pasture field and fence-posts, and so its reduction also alleviated this issue. In this situation, regular monitoring and management was straightforward. However, more sustainable, expensive solutions could be employed at this location such as raising the track level with stone, or installing a flow device. At the current time, this 'little and often' management has been the most cost-effective mitigation option.

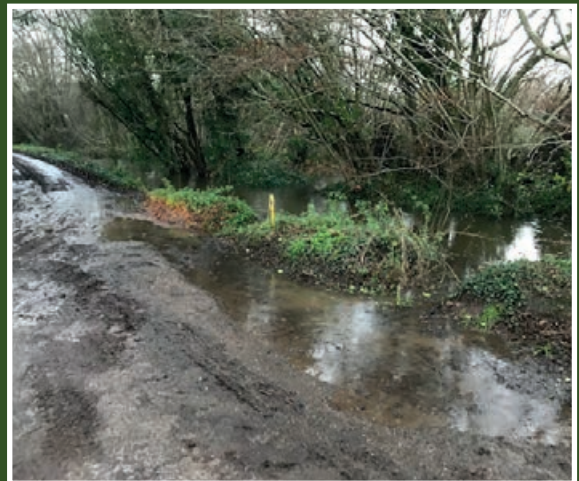
↑ Highways impacts

A single highways impact was detected during the 5-year trial. A beaver dam built within 20 m of a small country lane caused impounded water to encroach slightly onto the edge of the road. The Highways team at Devon County Council were made aware and did not identify a need to intervene. The landowners, Clinton Devon Estates, have occasionally reduced the crest level of the dam to lower water levels and mitigate this impact, and allay the concerns of a local resident. The location is adjacent to the Estate's Forest yard with 24 hour access required.

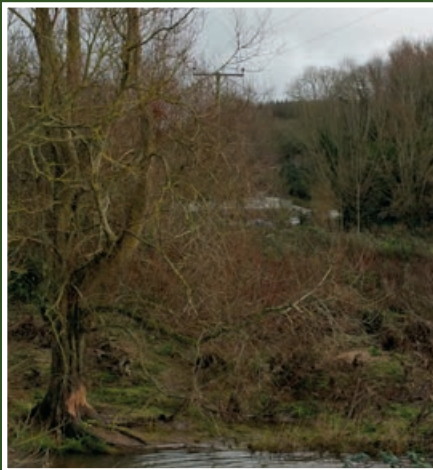
← Electricity or telecommunications infrastructure

There have been no recorded negative effects on electricity or telecommunications infrastructure. On two occasions large riverside willow trees growing adjacent to powerlines were being gnawed by beavers, and were proactively protected to prevent any detrimental impacts. In one case, in consultation with the landowner, Western Power Distribution decided to coppice the willow tree, as is normal practice when trees grow within ca. 3 m of power lines.

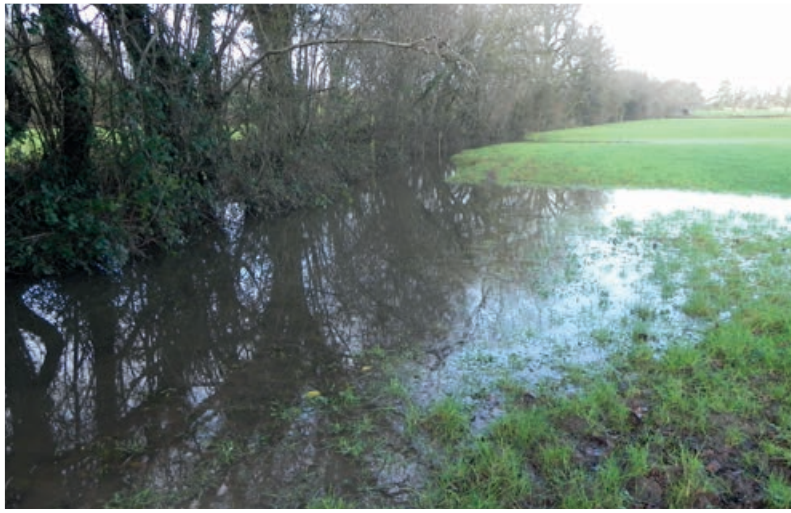
← Cadhay Stream

In winter 2015/16 a series of three beaver dams was constructed in a drainage ditch in the floodplain north of Ottery St Mary. One of the three dams was 80 cm in height and 0.5 ha of the low-lying adjacent pasture was flooded and waterlogged for a number of weeks during the winter period. This dam was removed by the tenant farmer and ROBT staff. Due to the season, there was no direct financial impact on the farm business, except the time taken by the farmer to manage the dam.

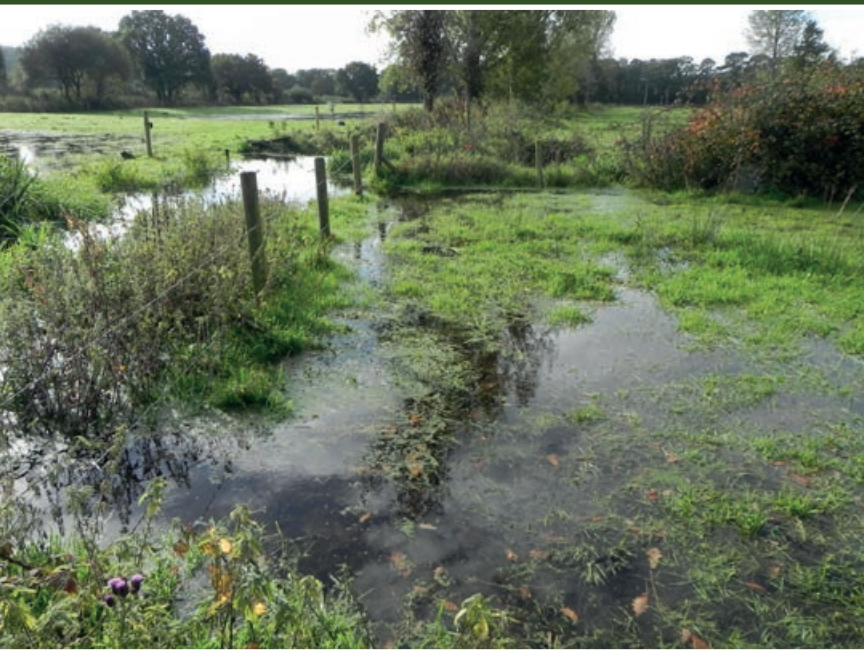
← Colaton Raleigh Stream (Case Study 1)

The Colaton Raleigh Stream site received the greatest intensity of beaver management resources.
