River Otter Beaver Trial

Science and Evidence Report

The River Otter Beaver Trial is a 5-year trial reintroduction of Eurasian beavers, *Castor fiber*, into the wild in south east Devon. It began with two family groups of beavers in 2015 which have now bred and dispersed throughout the catchment. The Science and Evidence Forum have overseen a detailed research programme, the findings of which are summarised within this report.

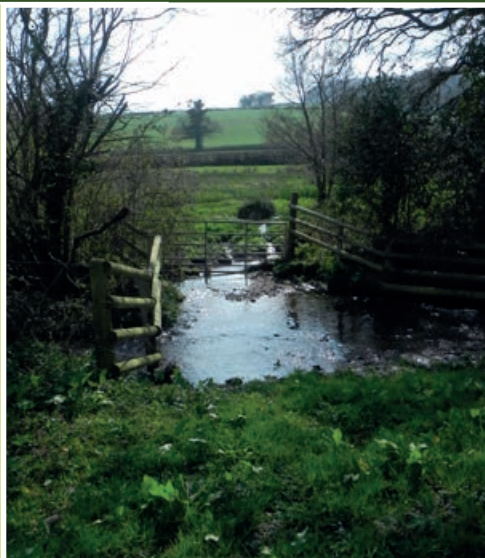
← Budleigh Brook (Case Study 2)

The sequence of dams on the Budleigh Brook upstream of East Budleigh have had a measurable impact on the peak flows downstream and the raised water levels have impacted on 0.4 ha of Grade 1 arable land.

A backlog of water behind a beaver dam prevented the sowing of 0.4 ha of organic 'first early' potatoes. The estimated gross margin forgone was £1495. Additionally, seed potatoes had been purchased that could not be planted. This constituted a further cost of £600. These estimates were made using data for organic first-early potatoes¹⁷.

The first early potatoes are one of two cash (as opposed to cover) crops from a 5-year rotation cycle. The second of these in the following year is usually barley. If the same area of land were affected in the following year (which is unknown at the time of writing), it is estimated from data for spring barley¹⁷ that this would constitute a lost gross margin of £227.

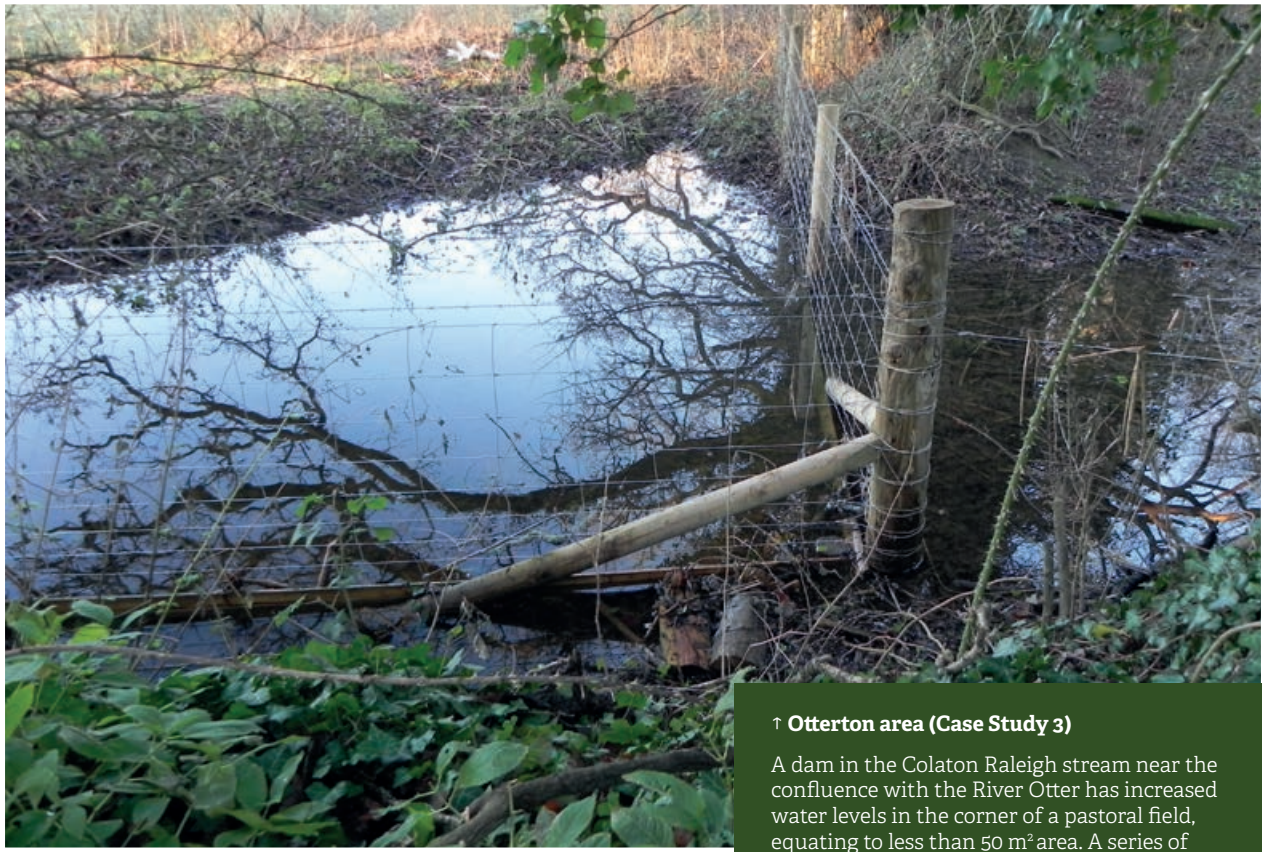
↑ Otterton area (Case Study 3)

A dam in the Colaton Raleigh stream near the confluence with the River Otter has increased water levels in the corner of a pastoral field, equating to less than 50 m² area. A series of fenceposts in this field corner have also been partially submerged during wet periods which is likely to reduce their lifespan. This dam was impacting on an access track, which combined with concerns by local anglers about potential sea trout passage in autumn, has led it to be reduced in height on a regular basis.

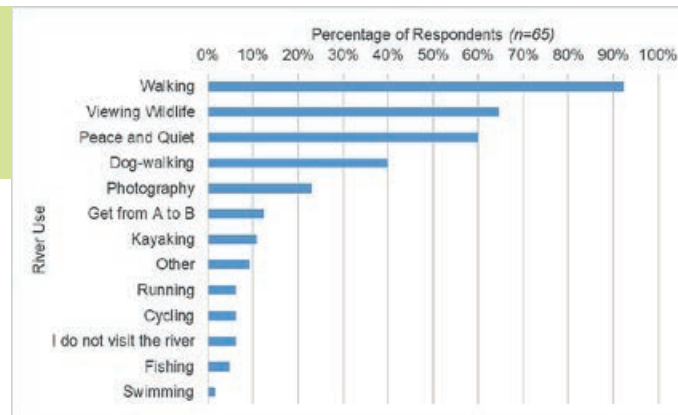
→ **Figure 1.8** Mail-return questionnaire respondents' use of the River Otter. Respondents were able to select multiple answers.

Residents in the community were asked how they used the river near to their village. Walking was the most frequently cited activity by the respondents, followed by viewing wildlife. Fewer than 10% of respondents indicated that they did not use the river.

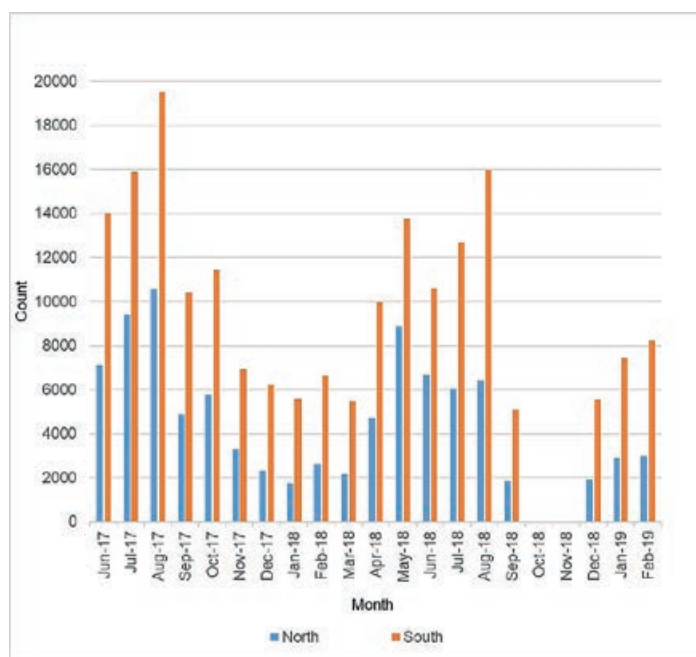
↑ **Figure 1.9** Footpath count data between installation in June 2017 and February 2019 (Data: East Devon AONB).

In general, the footpath south of Otterton saw a higher number of monthly footpath counts, with both counters indicating increased use of the footpath in the summer months coinciding with the presence of beavers. In the summer of 2017, a family of beavers (with kits) was easily observable as they had established a lodge upstream of the village. In the winter of that year, the beavers then moved away from this location. As such, it is possible to compare the peak 'beaver-watching' months of June to September between a year where beavers were present and easily observable, and a year in which they were not.

For both footpath counters, a statistically significant reduction in footpath counts was identified between 2017 and 2018. This difference correlates with the movement of beavers away from the vicinity, which seems the most likely explanation. However a number of factors may have contributed towards this reduction in footpath use, such as differences in weather conditions.

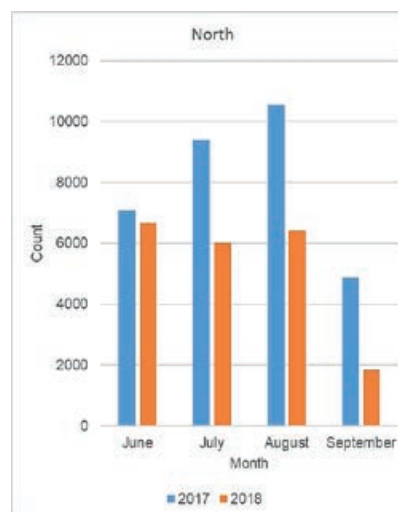
← **Figure 1.10** Differences in footpath counts between the summers of 2017 and 2018 heading north from Otterton village towards the main beaver watching location and south towards the Estuary (Data: East Devon AONB).

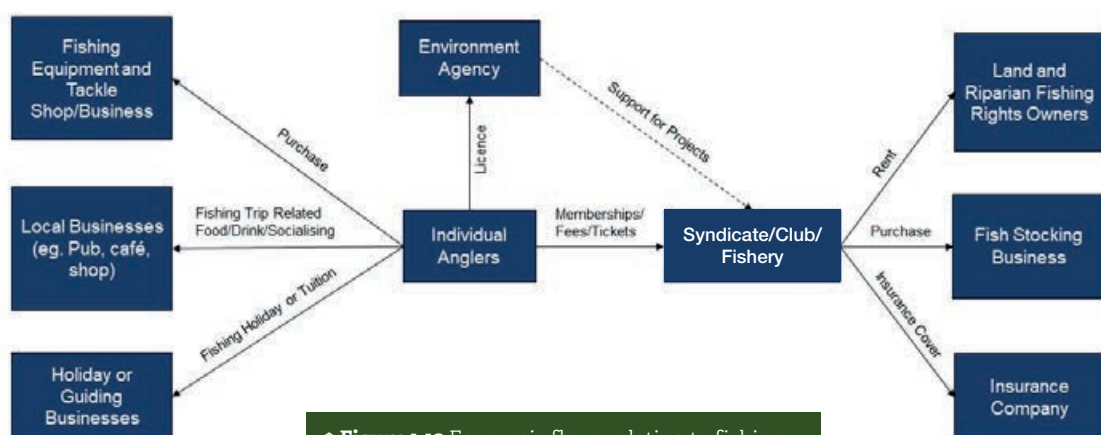
↑ **Figure 1.12** Economic flows relating to fishing activity in the River Otter catchment.

The economic flows pertaining to fishing within the catchment have been identified and provide a profile of fishing-related economic activity. By doing so, we identified that if beavers are found later to impact on the recreational fishing economy (either positively or negatively) this would likely occur by first influencing an individual angler's activity. This could then have knock-on impacts on factors such as syndicates and/or riparian rights.

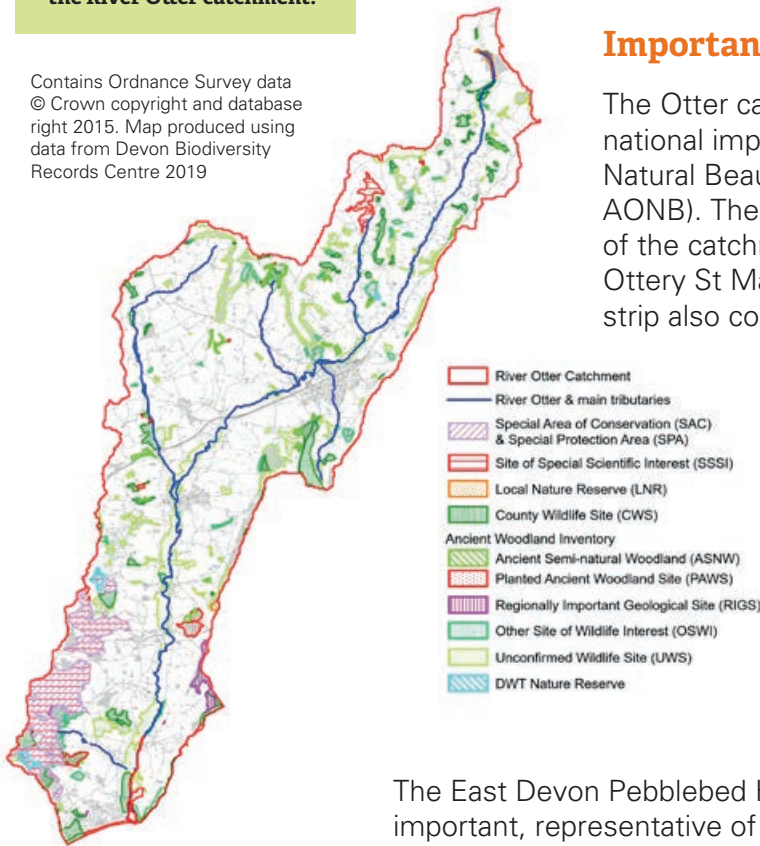
↓ **Figure 2.1** Map showing the designated sites within the River Otter catchment.

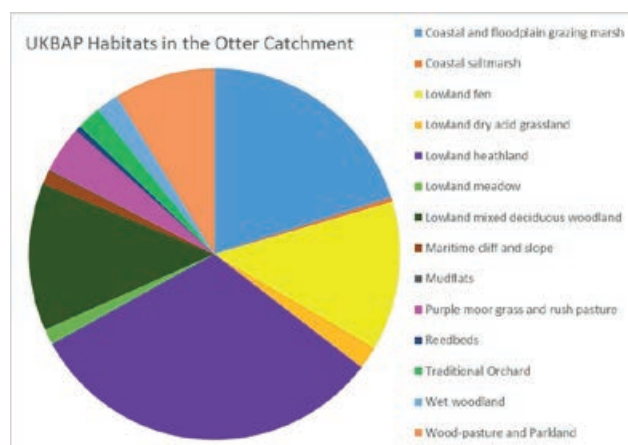
↑ **Figure 2.2 Map and chart showing extent of different Biodiversity Action Plan (BAP) habitats within the River Otter catchment. These make up 12% of the catchment area.** Contains Ordnance Survey data © Crown copyright and database right 2015. Map produced using data from Devon Biodiversity Records Centre 2019

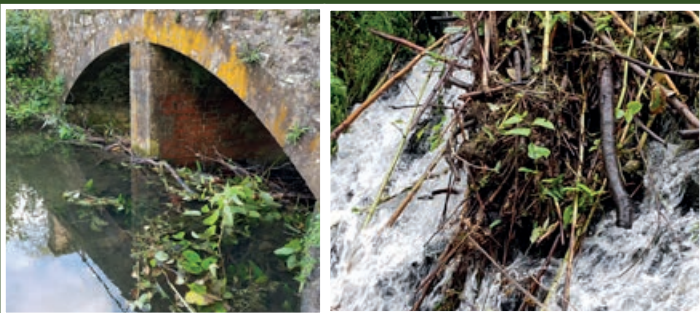
↑ On one site, a stand of Bohemian knotweed *Fallopia x bohemica* growing within 10 m of the water's edge appears to have been used by the beavers as dam building material – in a similar way to their use of riverside maize. The plant appears to be growing in the dam where it has been deposited, although there is no certainty about whether it was placed or was washed there.

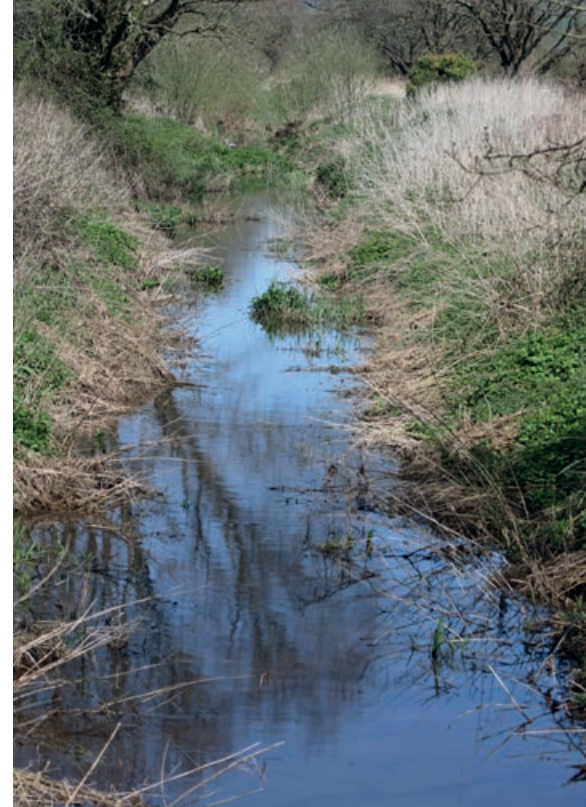
↑ In total 1.9 km of the 594 km of watercourses within the River Otter catchment was impounded by beaver dams in October 2019, which equates to 0.31%. This includes 813 m of floodplain ditch system in the Colaton Raleigh stream.

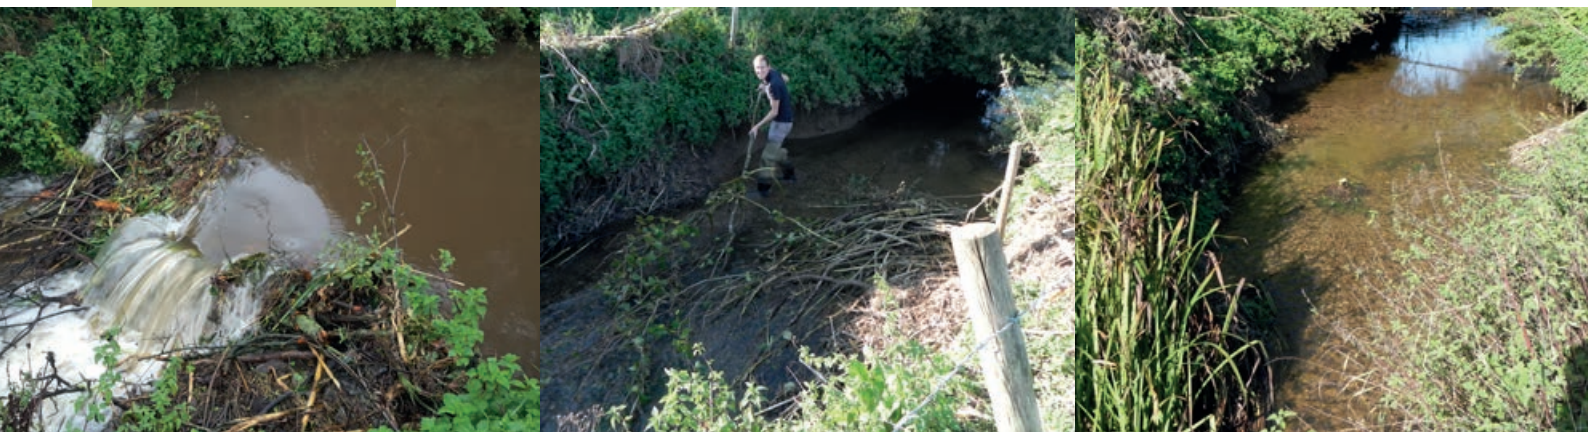
↓ In 2018 the summer dam created by the beavers to access maize in the lower River Tale was removed on a number of occasions over the course of 2 months. A new riffle is all that remains as a result of the gravel deposition that occurred when the dam was in place.

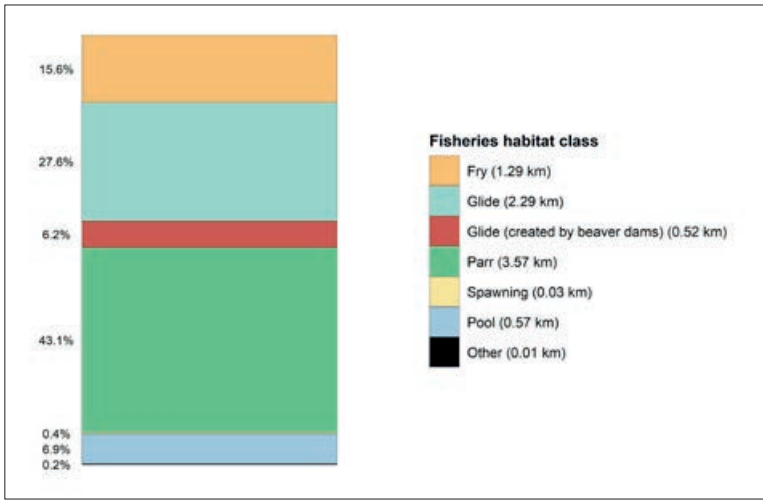
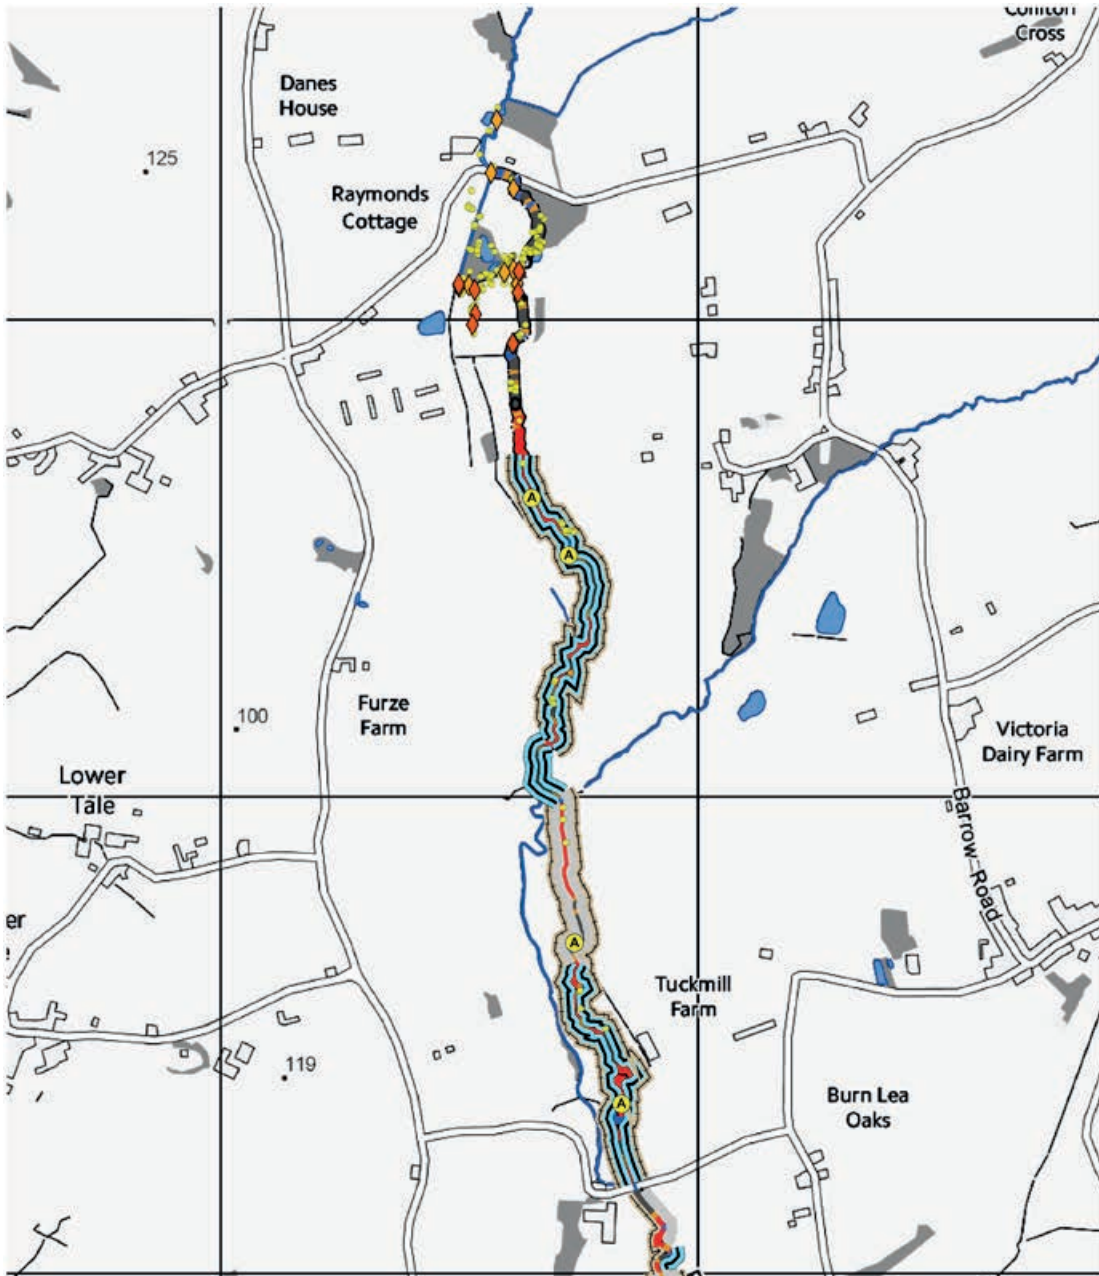
Figure 2.5 A survey of the lower 8.3 km of the River Tale by Westcountry Rivers Trust (WRT) in 2019 quantified the salmonid (salmon and trout) habitats present. The habitat types are broken down into the various stages of the salmonid life cycle using WRT's fisheries walkover manual. (Sample map below).

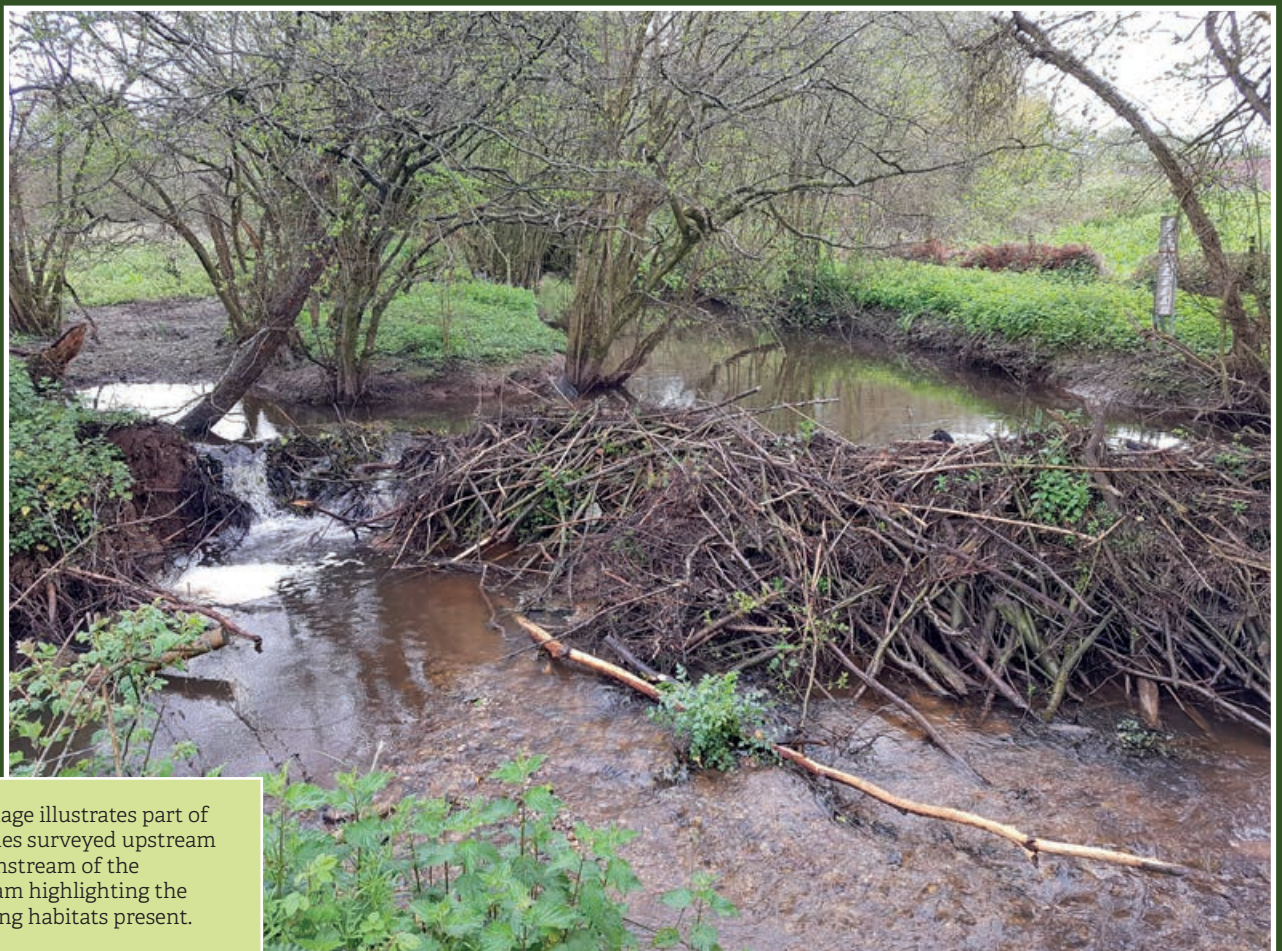
→ This image illustrates part of the reaches surveyed upstream and downstream of the beaver dam highlighting the contrasting habitats present.

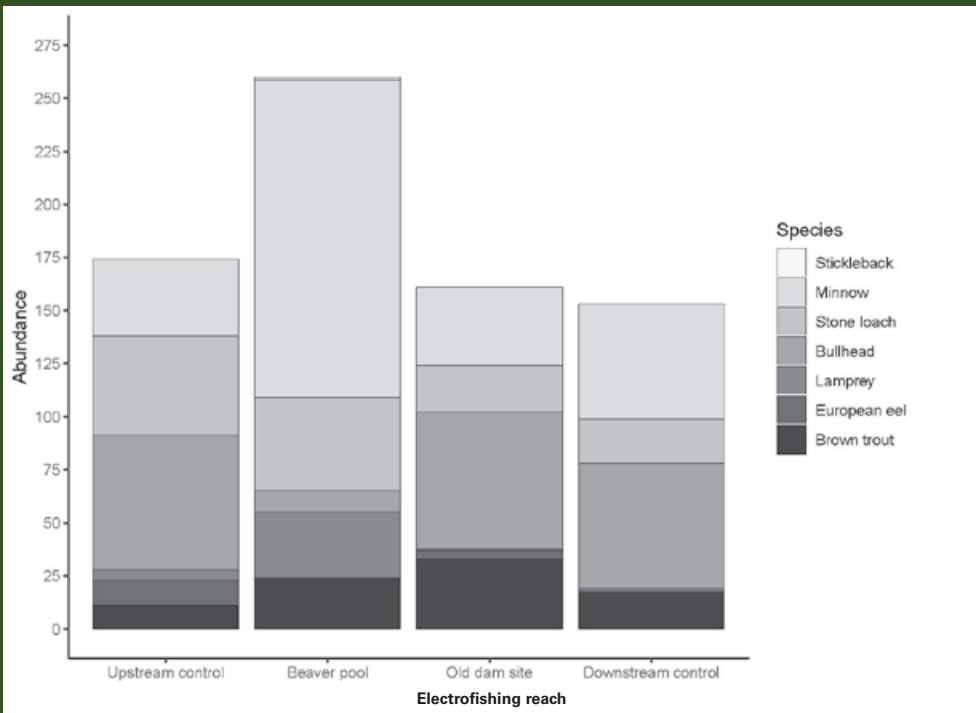
← Total abundance of fish within four reaches sampled in August 2019 including a beaver pool (glide) formed by a dam in place throughout 2019, and a reach immediately downstream where a dam had been washed out in 2018. Bars are stratified by fish species.

Figure 2.6 Results of electrofishing survey work by the University of Southampton on a short stretch of the River Tale demonstrates that the effects of a dam in reducing velocity and increasing depth in the resulting pool (glide) has a marked effect on the fish community. The beaver pool supports the highest total fish biomass with more and larger trout than either the upstream or downstream controls. In contrast the shallow, swift flowing conditions created where the previous beaver dam had washed away provided good habitat for juvenile trout which were abundant.

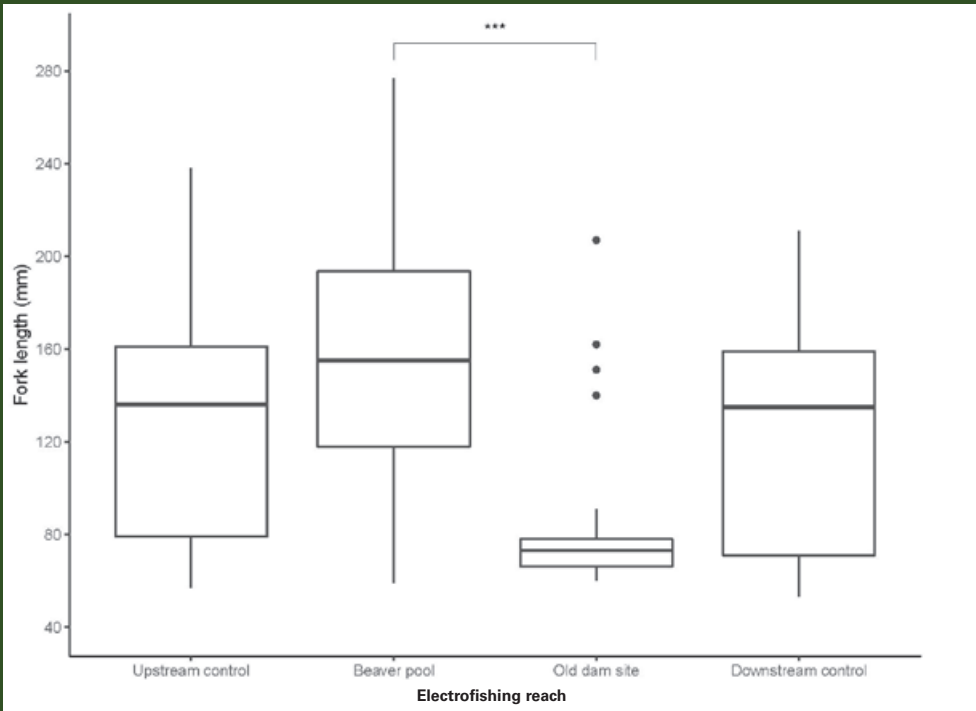
← Fork length of brown trout in the four reaches sampled in August 2019. The horizontal lines represent the median value, and boxes define the 25th and 75th percentile. The whiskers represent maximum and minimum values, excluding outliers. Outliers (> 1.5 x the interquartile range) are shown as dots. Significant differences are highlighted with horizontal lines above boxplots.

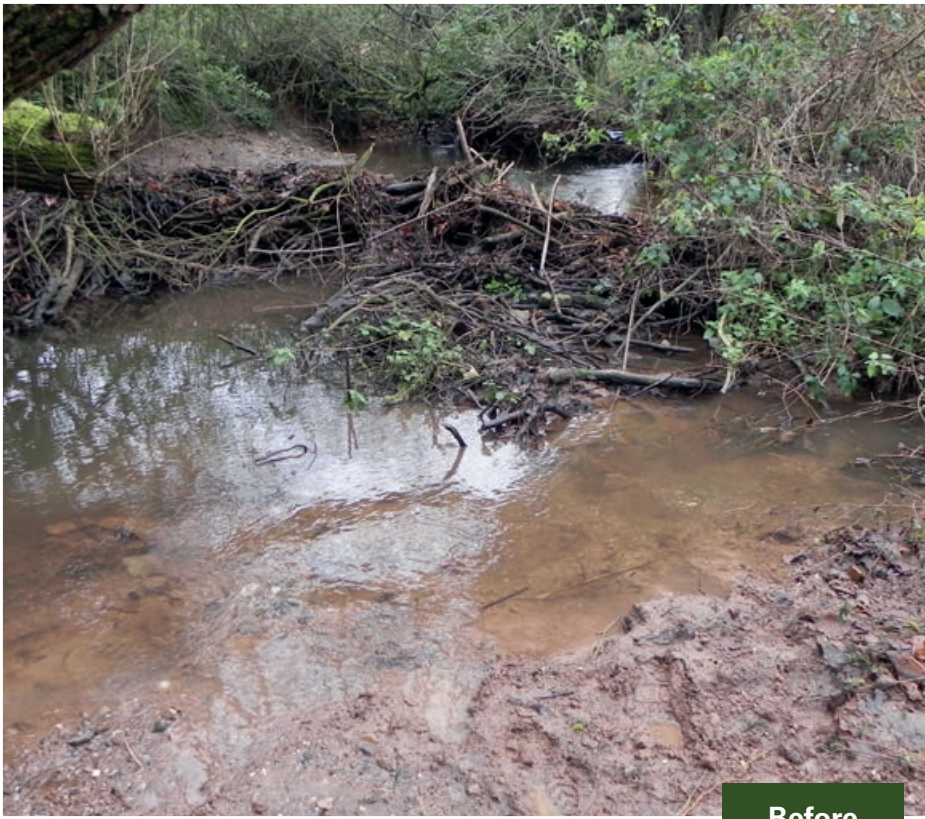
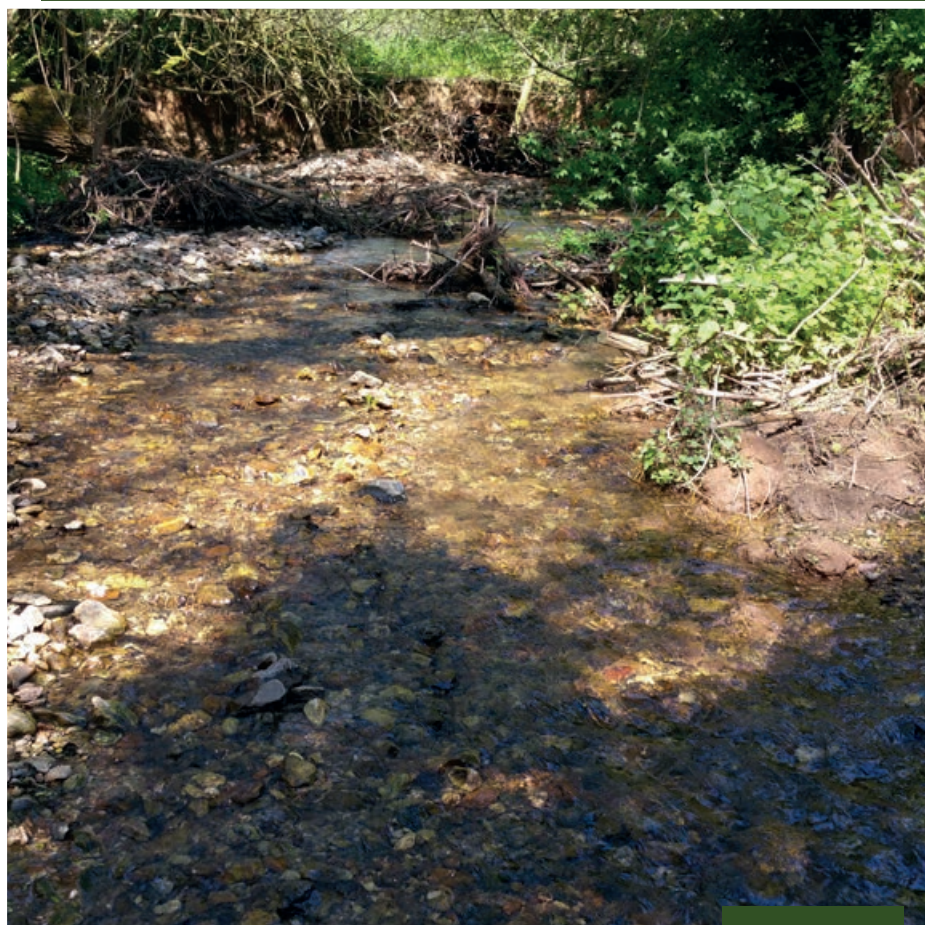
Before

After

The high energy River Tale at Clyst William Cross has demonstrated the most interesting effects of beaver damming on fish habitat. Since 2016 a sequence of dams has been repeatedly built and washed away during high flows, resulting in significant changes to the channel morphology. During periods when dams impound water, sediments and gravels are deposited in the pools, and erosion of the banks around the dams has occurred. As dams breach during high flows, fine sediments are flushed downstream and larger sediments redistributed, creating new riffles and gravel beds. This has resulted in a noticeable increase in bed level height in these reaches and a wider, more meandering and multi-threaded channel. With the creation of new dams elsewhere, the process is repeated. This results in the restoration of dynamic morphological processes and an increase in habitat variability within the reach, including deep pools, mobile gravels, extensive in-channel woody material, eroding banks and other natural features.

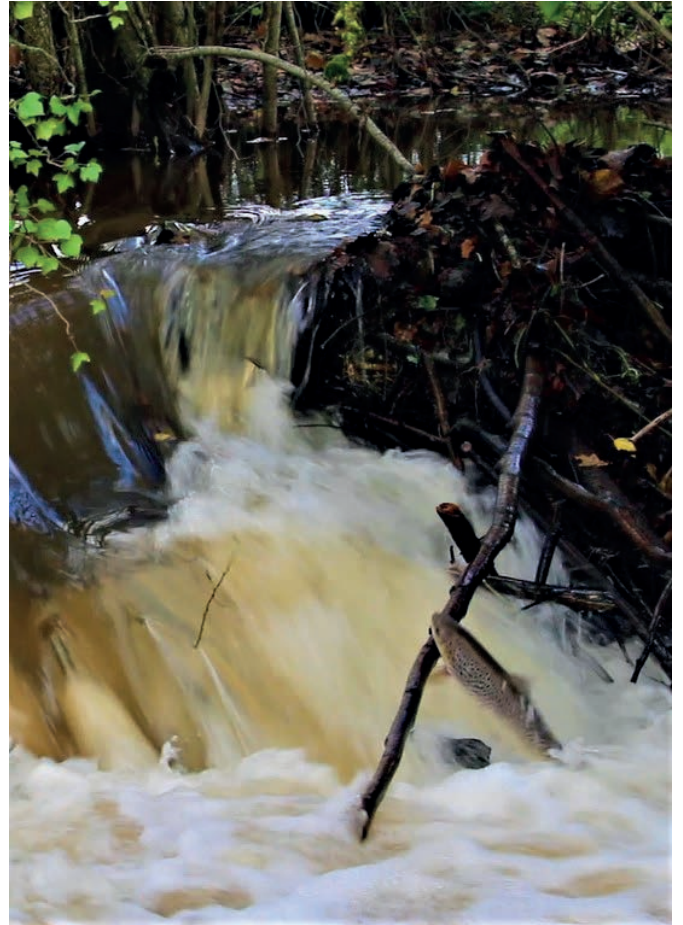
On 26th November 2019, sea trout were observed migrating at a beaver dam site at Clyst Williams Cross. The trout were jumping and attempting to make their way over the dam of approximately 1.5 metres in height (from river bed to dam crest). Following prolonged rainfall, the high flows had overtopped the crest of the dam and created a focused stream where the trout were jumping.

Many attempts were unsuccessful due to factors such as jumping from too far back, jumping in the wrong direction, or being obstructed by an overhanging piece of woody material. Six film clips of failed attempts were captured, demonstrating examples of each of these reasons.

The films demonstrate that sea trout were attempting to pass the dam and that, in high flow conditions, this dam was passable for some fish.

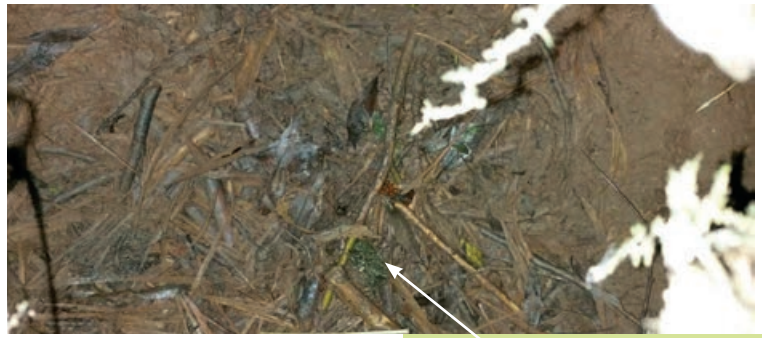
↑ Otters rely on natural holes in riverbanks as holt sites, and spraints found inside collapsed beaver burrows indicate that they are being used for this purpose.

The River Otter supports a healthy otter population, and their interaction with beavers is of interest to many stakeholders. Beavers and otters are both frequently encountered along the same stretch of river in the evenings. Being unlikely to dig their own burrows, otters rely on natural holes in riverbanks as holts. On two occasions since 2015, otter spraints (droppings) have been recorded by ROBT surveyors in the chambers of collapsed beaver burrows in the lower River Otter catchment.

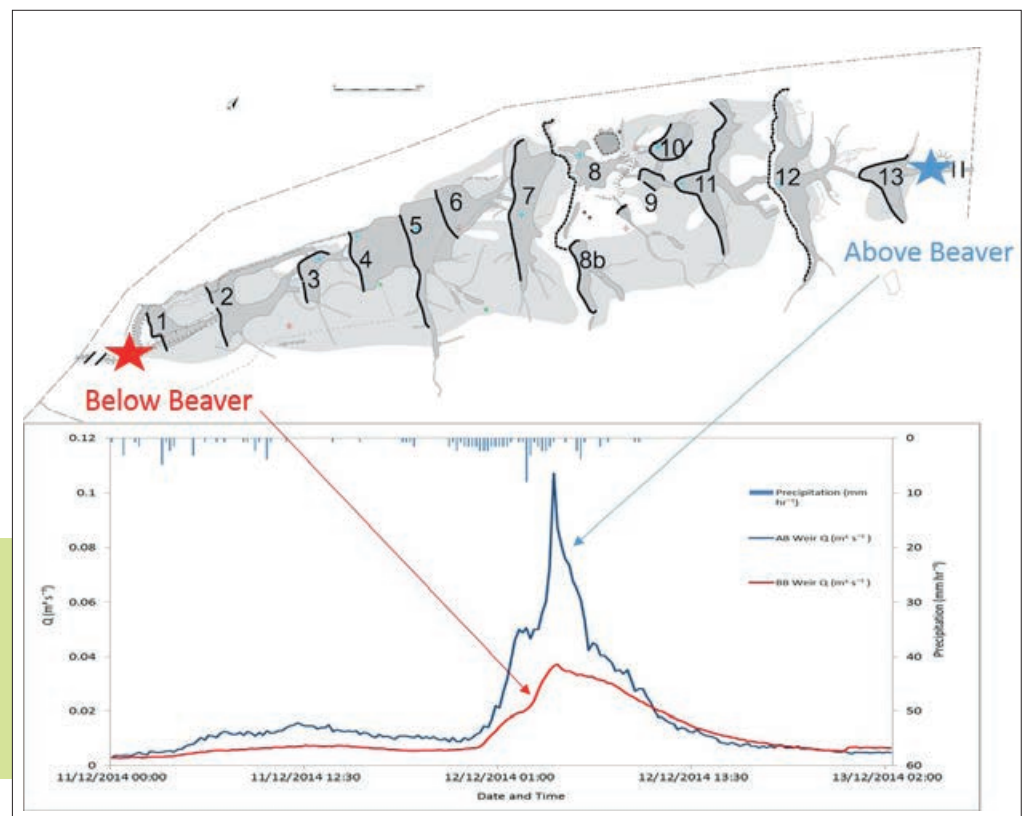
→ **Figure 3.2** Map showing sequence of 13 beaver dams along 183 m of watercourse at Enclosed Beaver Site, with graph showing an example of flow data measured upstream (blue) and downstream (red) during a single high flow event.

The beaver dams slow the flow of water. During storms, on average, peak flows were 30% lower leaving the site than entering. The lag time between peak flow entering the site and peak flow leaving the site was on average one hour, over a distance of only 183 m. Even in saturated conditions and for the largest monitored flood events, similar effects are observed due to the hydraulic roughness of the dams and felled trees and the leaky nature of the dams.

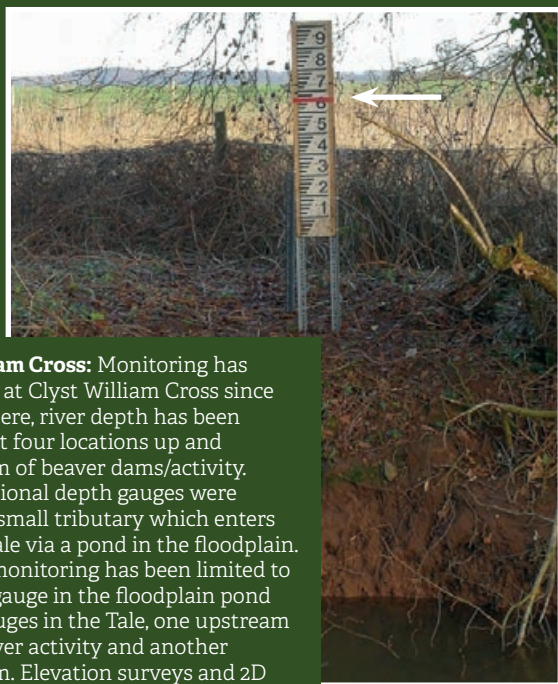
Clyst William Cross: Monitoring has taken place at Clyst William Cross since May 2016. Here, river depth has been measured at four locations up and downstream of beaver dams/activity. Three additional depth gauges were placed in a small tributary which enters the River Tale via a pond in the floodplain. From 2018 monitoring has been limited to one depth gauge in the floodplain pond and two gauges in the Tale, one upstream of core beaver activity and another downstream. Elevation surveys and 2D hydrological modelling of this site has enabled the installation of a stage board to demonstrate the height a beaver dam would need to reach to cause water to back up to the road bridge upstream.

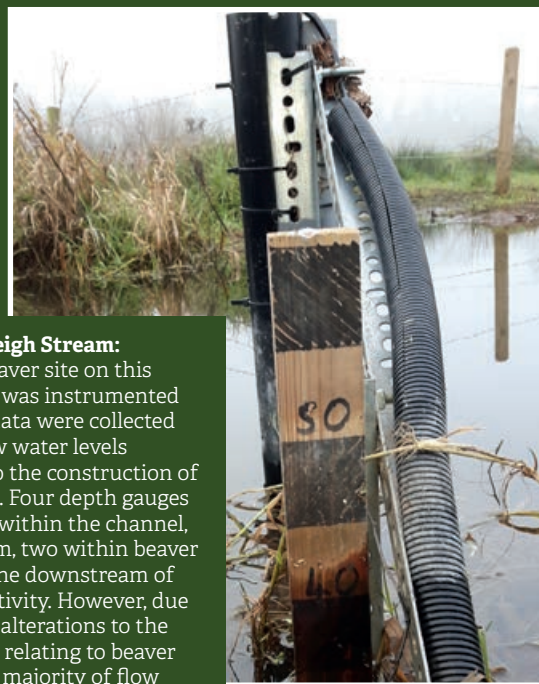
Colaton Raleigh Stream: The main beaver site on this watercourse was instrumented in 2016 and data were collected showing how water levels responded to the construction of beaver dams. Four depth gauges were placed within the channel, one upstream, two within beaver ponds and one downstream of damming activity. However, due to upstream alterations to the channel (not relating to beaver activity), the majority of flow is no longer conveyed along this channel and consequently, in November 2018, all gauging equipment was removed from the site.

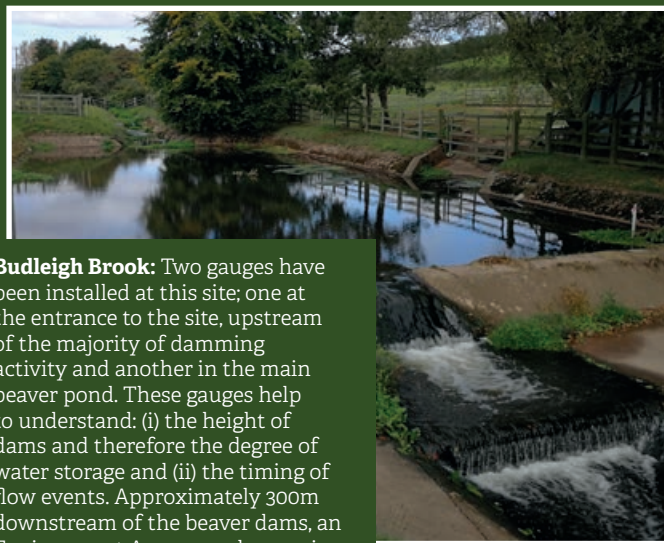
Budleigh Brook: Two gauges have been installed at this site; one at the entrance to the site, upstream of the majority of damming activity and another in the main beaver pond. These gauges help to understand: (i) the height of dams and therefore the degree of water storage and (ii) the timing of flow events. Approximately 300m downstream of the beaver dams, an Environment Agency early warning gauging station records water depth at 15 minute intervals (picture). With records dating back to July 2009, this gauge provides vital pre-beaver flow data to compare with post-beaver flows over the last 2-3 years. This depth data has been used to estimate river flow using established weir rating equations⁶.

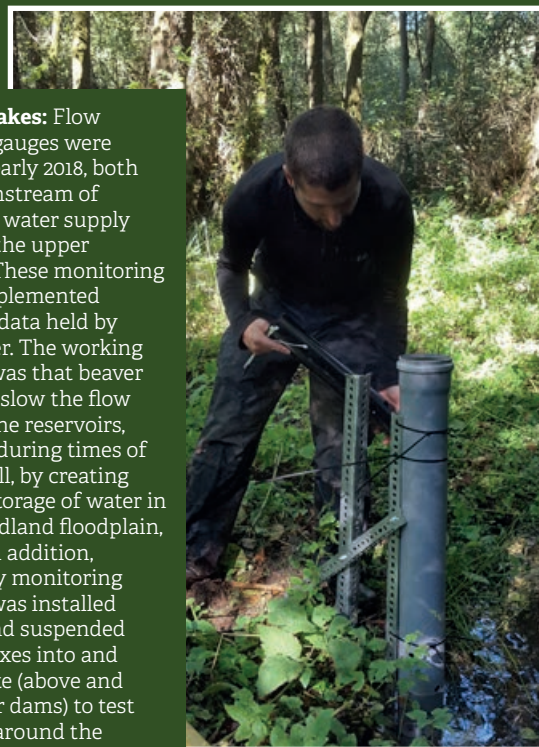
Otterhead Lakes: Flow monitoring gauges were installed in early 2018, both up and downstream of the drinking water supply reservoir in the upper catchment. These monitoring stations supplemented longer-term data held by Wessex Water. The working hypothesis was that beaver dams would slow the flow of water to the reservoirs, particularly during times of heavy rainfall, by creating significant storage of water in the wet-woodland floodplain, upstream. In addition, water quality monitoring equipment was installed to understand suspended sediment fluxes into and out of the site (above and below beaver dams) to test hypotheses around the impact of beaver dams on reservoir siltation³.

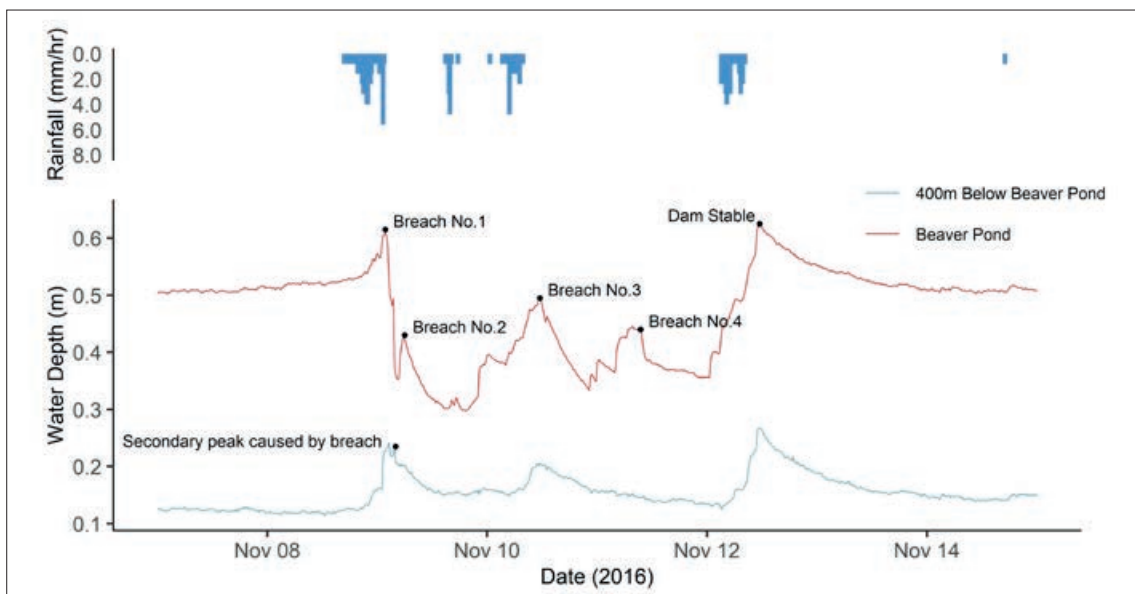
← **Figure 3.3** Watercourse hydrograph immediately upstream of beaver dam (red) and 400m downstream (blue) during a partial breach of the dam during a high flow event in November 2016. During the high flow event that caused the breach, there is a lower secondary peak observed downstream which is likely to be the result of the dam failure. It is also possible to see how the beaver dam collapsed and was rebuilt several times before it re-stabilised.

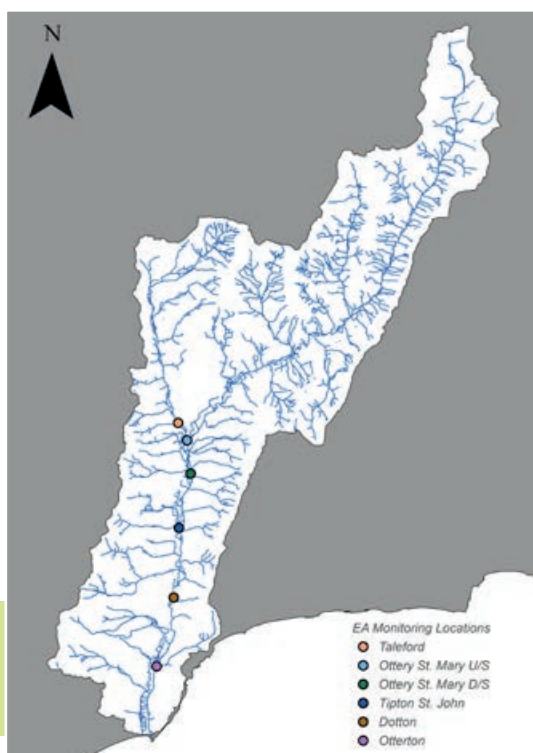
→ **Figure 3.5** Locations and description of EA invertebrate sampling locations.

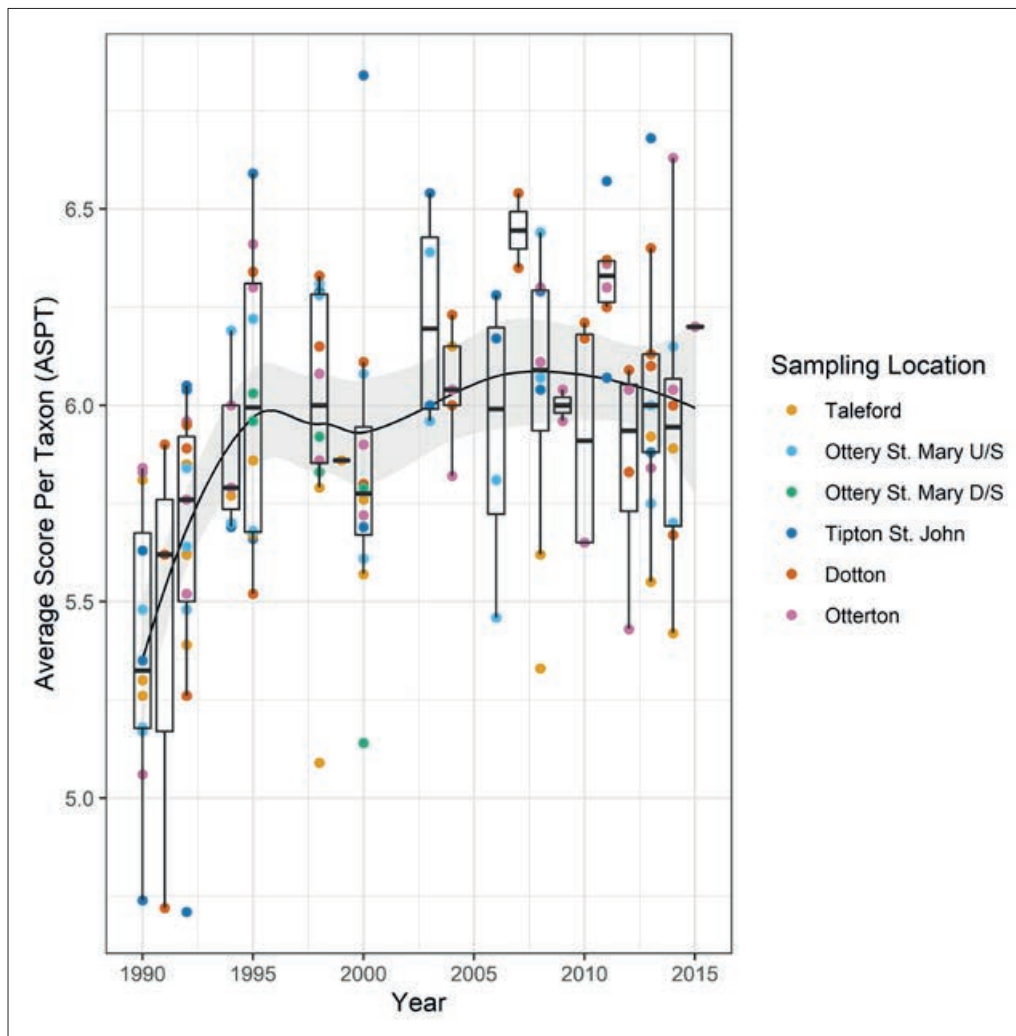
← **Figure 3.6** Plot indicating the change in the average (BMWP) score per taxon (ASPT) (i.e. per macro-invertebrate species) for all ASPT (EA monitoring sites) between 1990 and 2015. The trend line indicates the change in ASPT across all sites combined. These data provide a valuable baseline for understanding future impacts of beavers on water quality and the macro-invertebrate community in the River Otter.

Through analysis of the EA macro-invertebrate data obtained during the 1990s (see Figure 3.6 for details) there was a clear increase in the invertebrate biomonitoring metrics (Biological Monitoring Working Party (BMWP) and Average Score Per Taxon (ASPT)) at most sampling sites. This can be attributed to improved farming practices, catchment management and wastewater treatment, thus reducing both diffuse and point source pollution. In general, recent surveys suggest that the river is therefore in moderate condition. The pattern of water quality status in the river mirrors that of lowland rivers in agricultural systems across the UK. The headwaters tend to be in the best condition and as the river progresses downstream it is subject to increased pollutant loading, with the worst condition in the lower reaches. Isolated low-scoring surveys confirm there are still significant nutrient loading pressures on the river. There is no clear change in the data set to suggest that beavers have, as yet, had any impact (either positive or negative) on water quality at EA monitoring sites in the River Otter catchment.

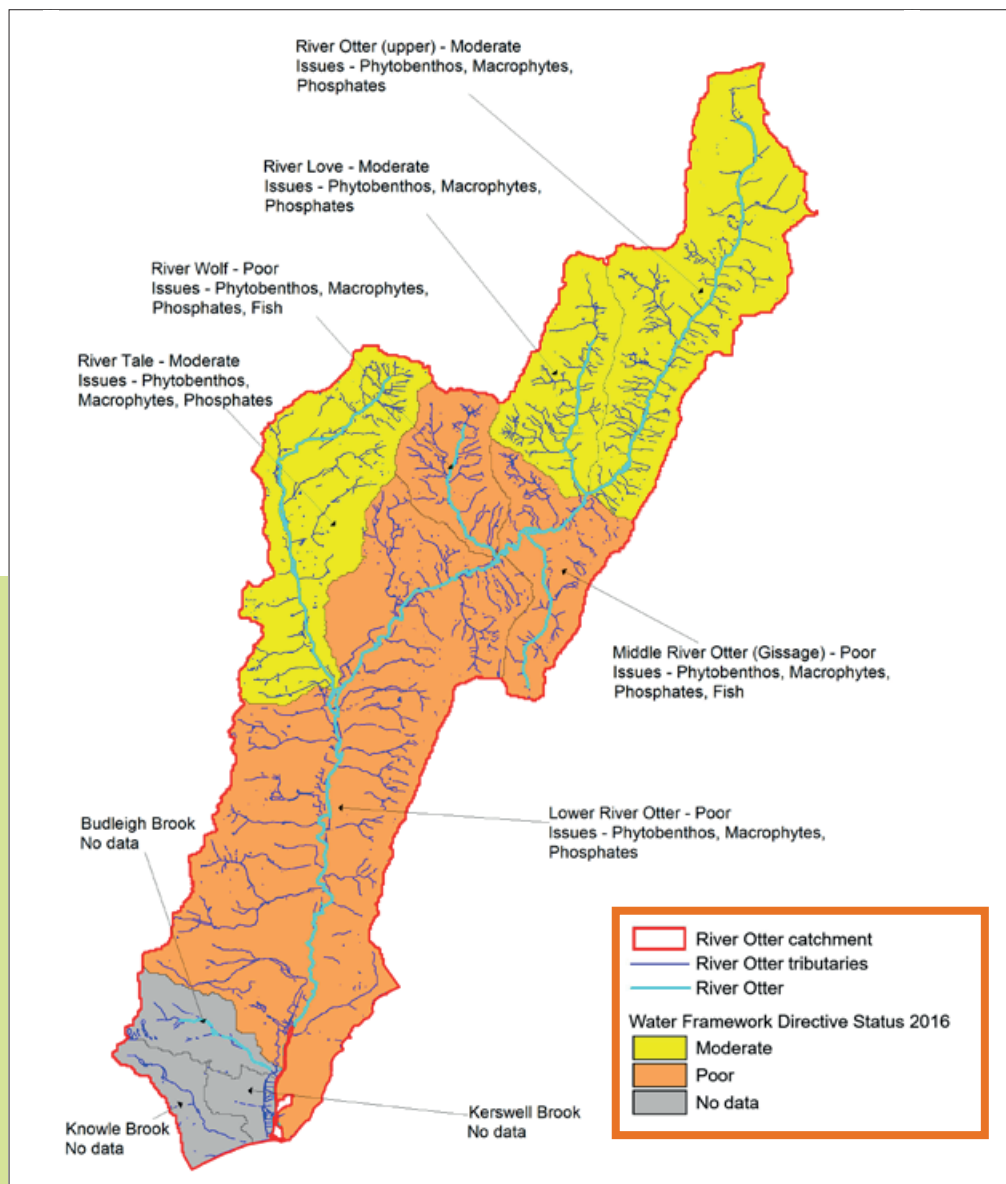
→ **Figure 3.4** The most recent Water Framework Directive classification shows the ecological status in 2016. The impact of beavers on this is unlikely to be significant in the short term, although their presence over time is likely to be responsible for significant improvements in water quality as dams in the headwaters reduce sediment and nutrient impacts downstream.

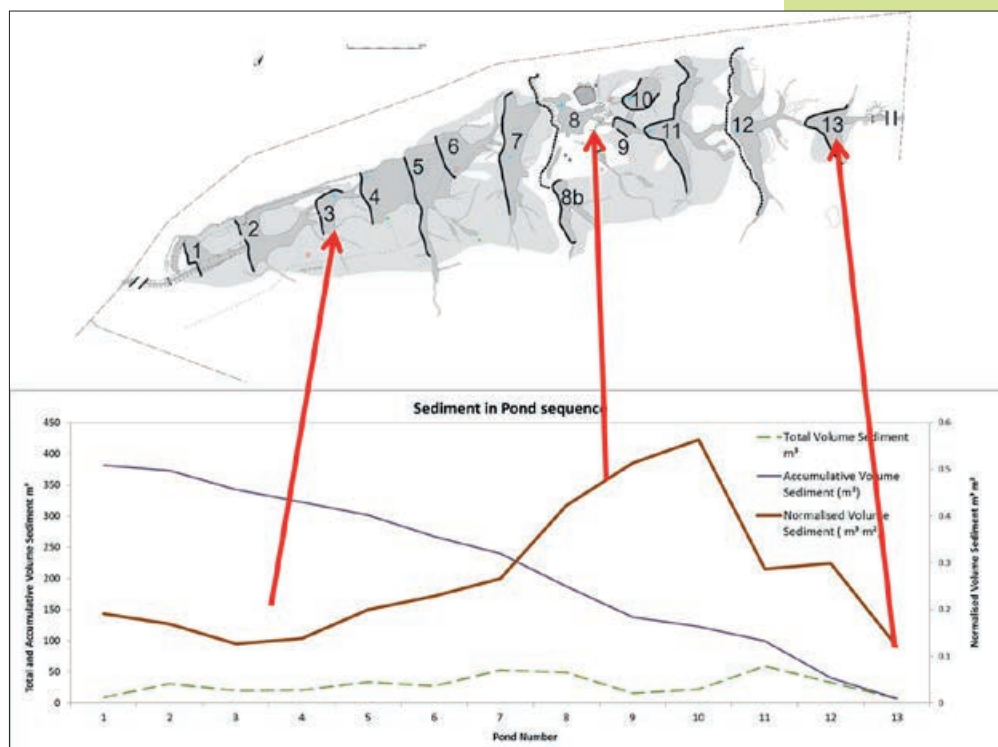
↓ **Figure 3.7**
Sediment storage within beaver ponds.

It is clear that pond size has the greatest control over storage; larger ponds hold more sediment per unit area, although position in dam sequence may play a role too. It was estimated that over 70 % of sediment within the ponds was sourced from the farmland upstream. Thus, beaver ponds may have a role to play in mitigating negative impacts of soil erosion and diffuse pollution from agriculture. At the time of sampling, it is estimated that ponds would have over 50% remaining storage capacity, even without continued modification by beavers of the site over time to maintain/increase capacity³.
