River Otter Beaver Trial

Science and Evidence Report

The River Otter Beaver Trial is a 5-year trial reintroduction of Eurasian beavers, *Castor fiber*, into the wild in south east Devon. It began with two family groups of beavers in 2015 which have now bred and dispersed throughout the catchment. The Science and Evidence Forum have overseen a detailed research programme, the findings of which are summarised within this report.

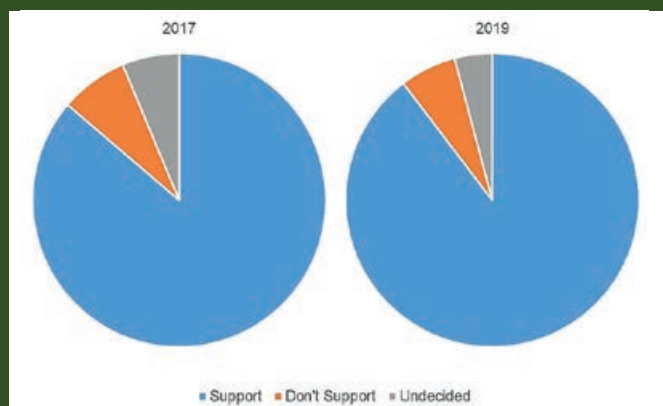
↑ **Figure 4.7** Relative proportions of all respondents in 2017 and 2019 who support or don't support the process of beaver reintroduction to Great Britain.

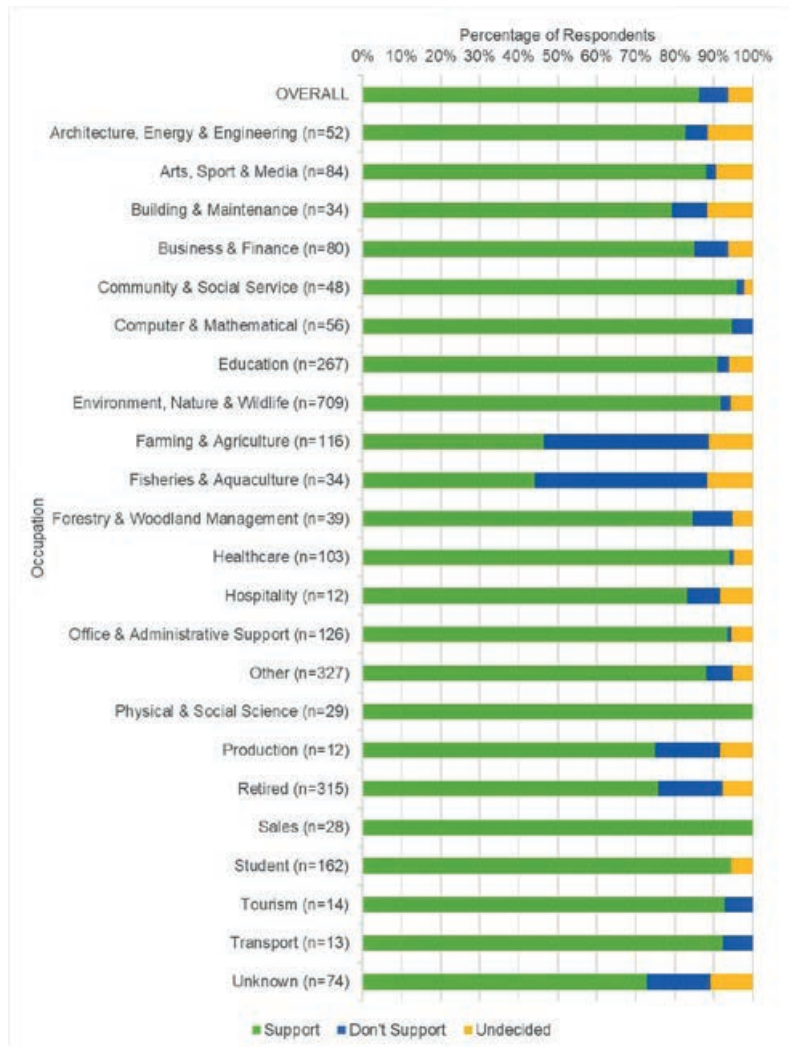
↑ **Figure 4.11** Levels of support for beaver reintroduction in relation to the occupations of all respondents in the 2017 nationwide questionnaire¹.

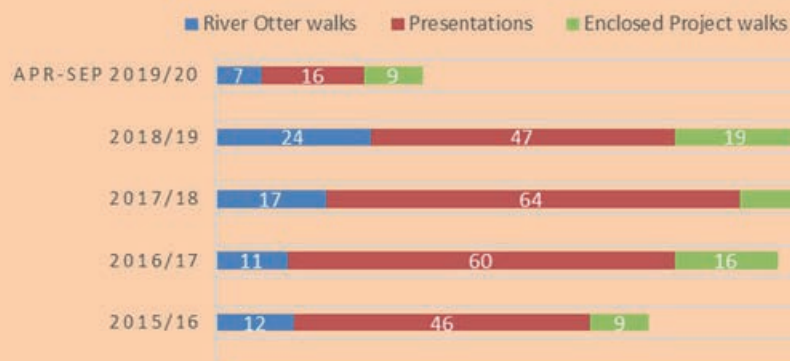
NUMBERS OF EVENTS HELD SINCE START OF ROBT

→ **Figure 4.13** In the first 4½ years of the Trial a total of 384 events were hosted or attended, at which an estimated 18,000 people were engaged directly with information about the beavers.

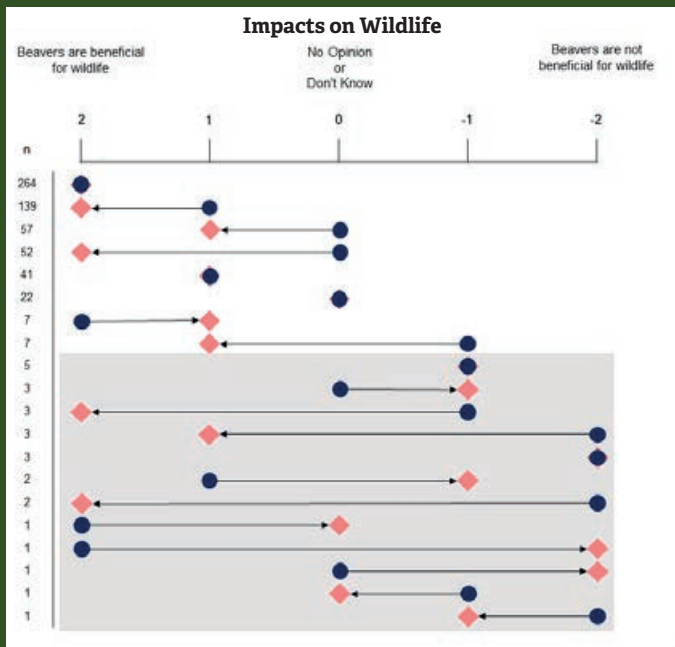
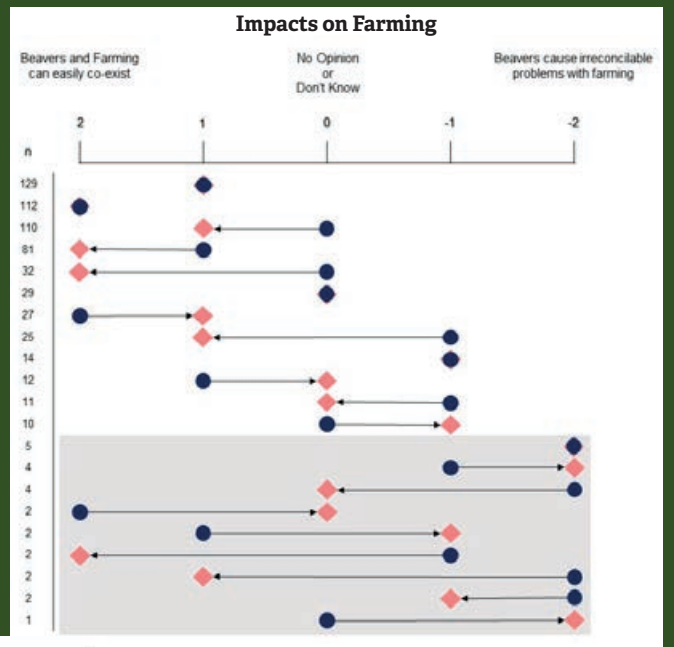
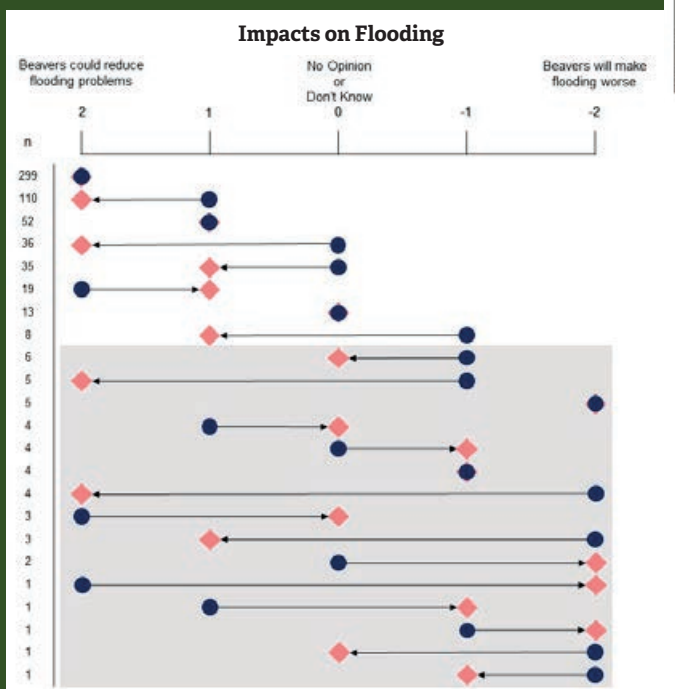
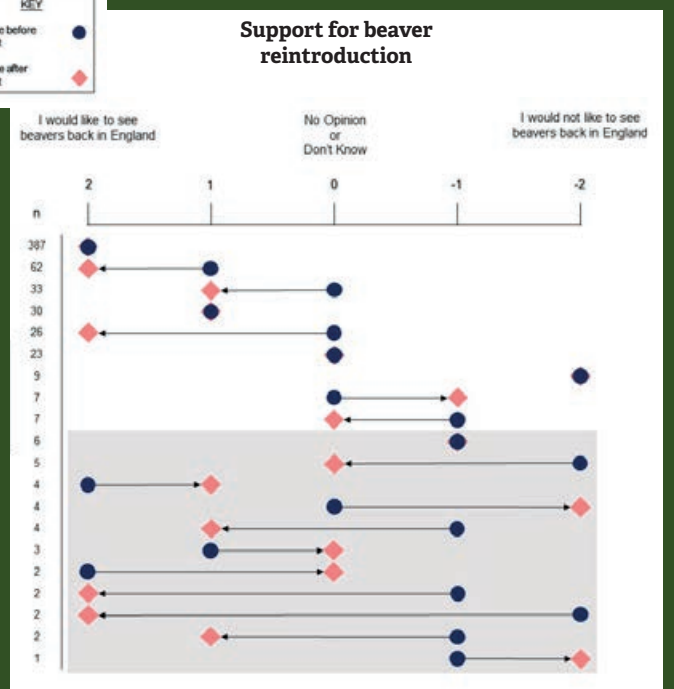
KEY
 Score before event: ●
 Score after event: ◆

† **Figure 4.14** Patterns of shift in attitude score between each pair of opposing statements. In these figures, each n refers to the number of people who demonstrated each shift pattern, and the area in grey indicates shift patterns exhibited in <1% of the respondent pool.

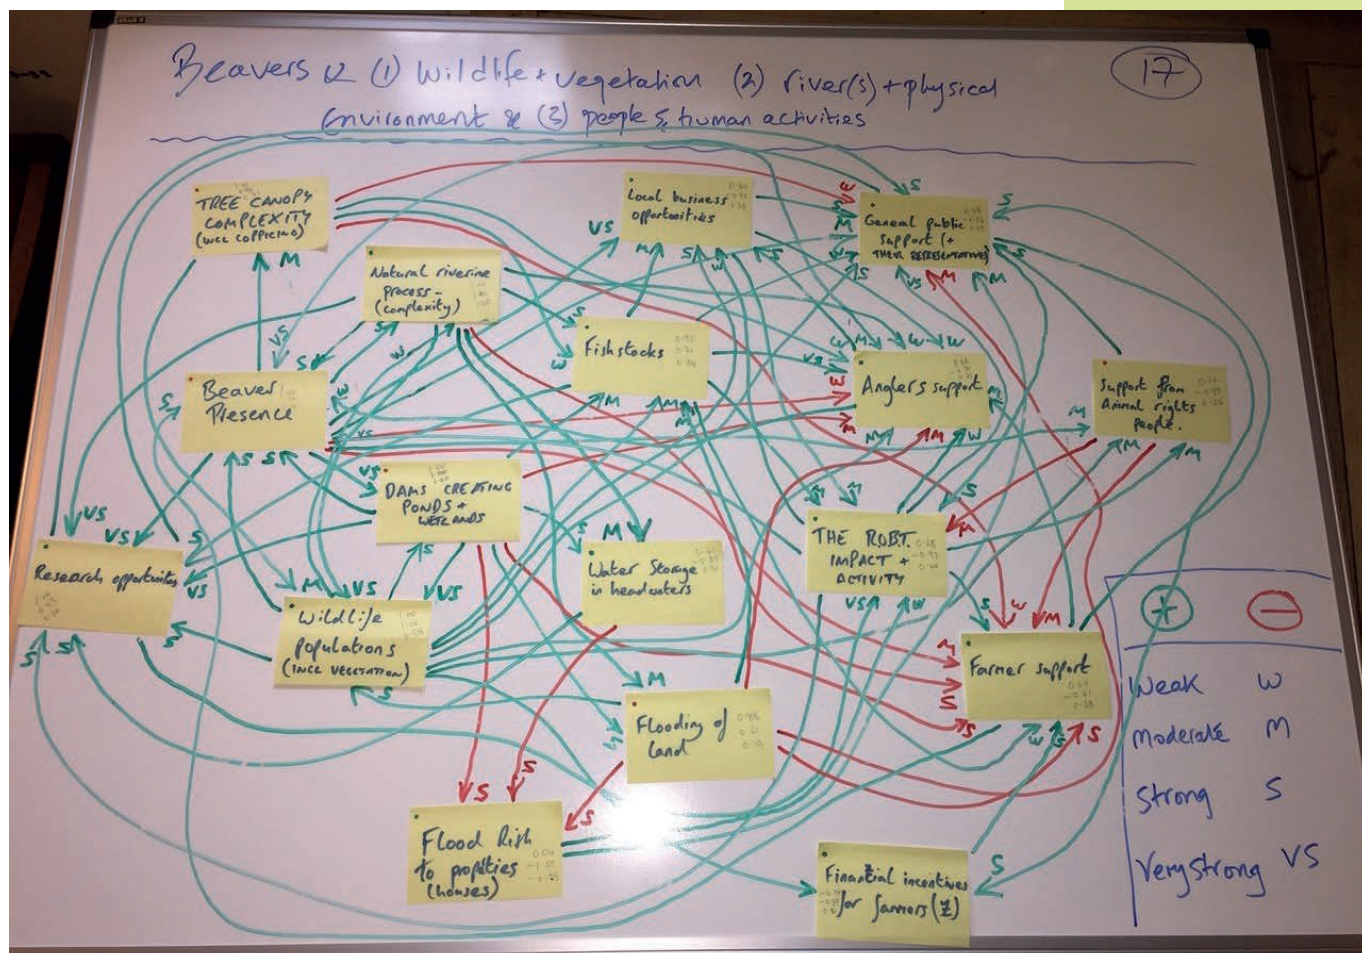
↓ **Figure 4.15** An example of a raw mental map collected as part of the stakeholder interview process (with permission).

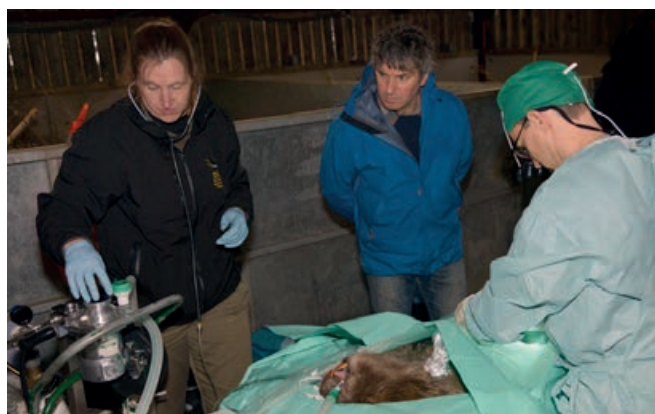
↑→ The captured beavers were placed under anaesthetic enabling detailed health screening to be conducted, including a lung wash for *Mycobacterium bovis* (bTB).

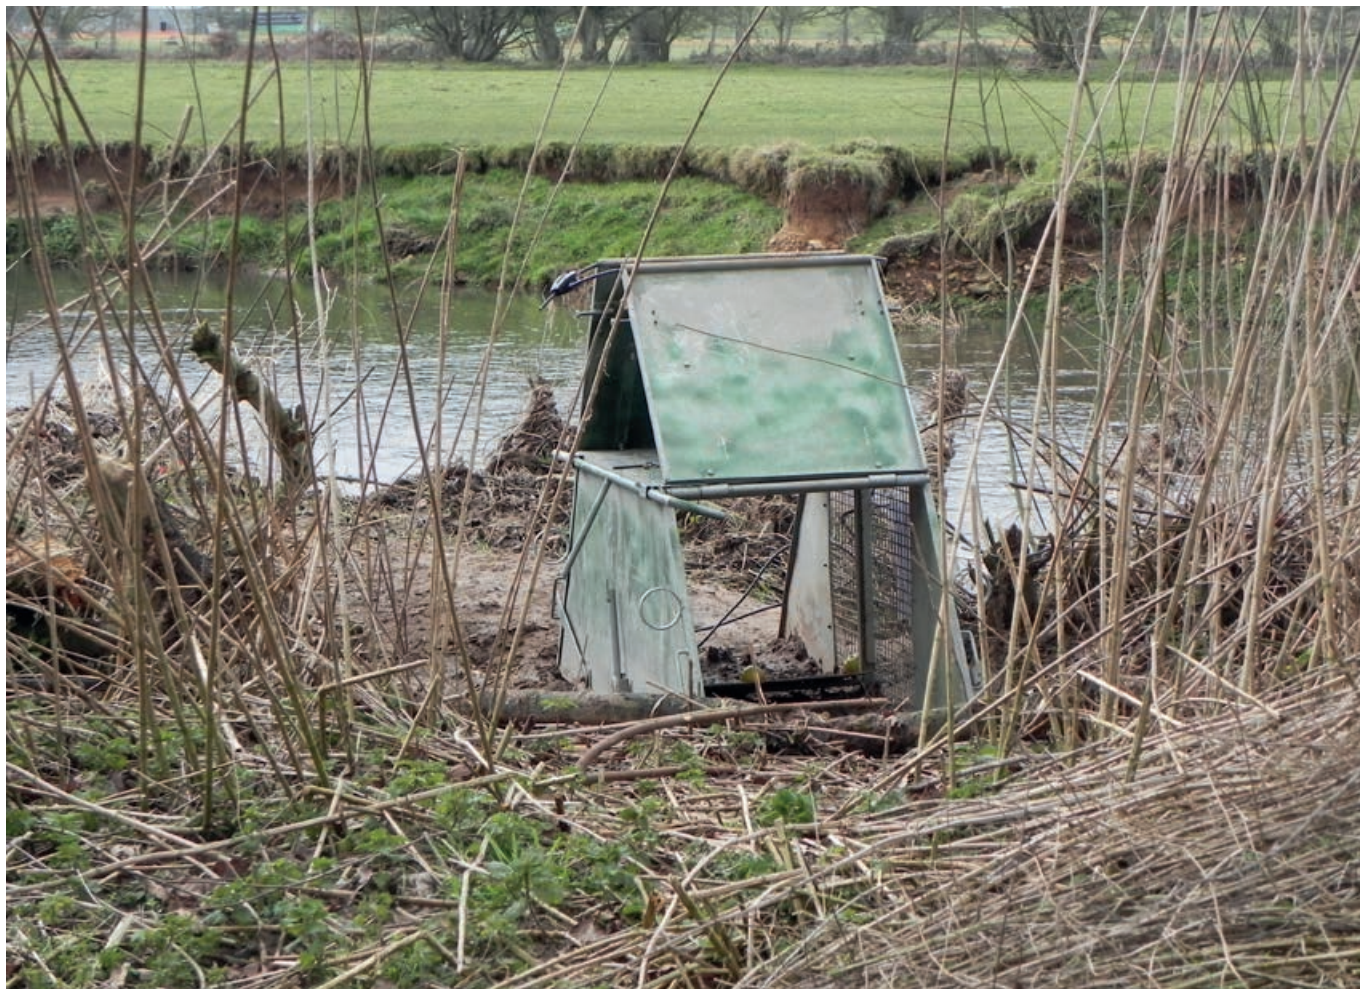
↑ When the ROBT licence was issued in February 2015, a team of ecologists from the Animal and Plant Health Agency (APHA) began trapping the wild beavers. Bavarian traps, specifically designed for the capture of Eurasian beaver, were sited so that they were aligned on natural beaver egress points from the river. Traps were locked open initially, baited with apples and monitored with remote cameras. Between 14th February and 4th March 2015, traps were set resulting in four adult beavers and one of the kits being caught. These were then transported to a holding facility nearby.

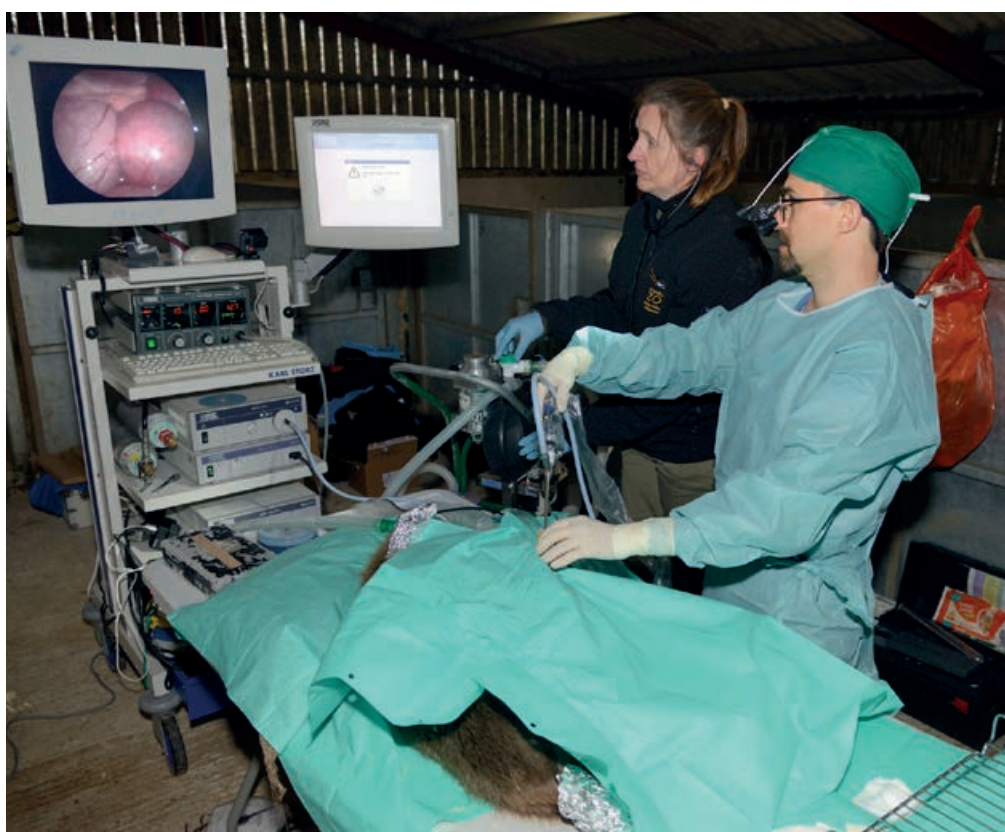
← A laparoscopic examination of the external surfaces of the internal organs, and ultrasound looking at the interior of organs focusing of the liver was conducted, searching for signs of the *E. multilocularis* cysts. This internal examination also revealed that both adult female beavers were pregnant at this time (mid-March 2015).

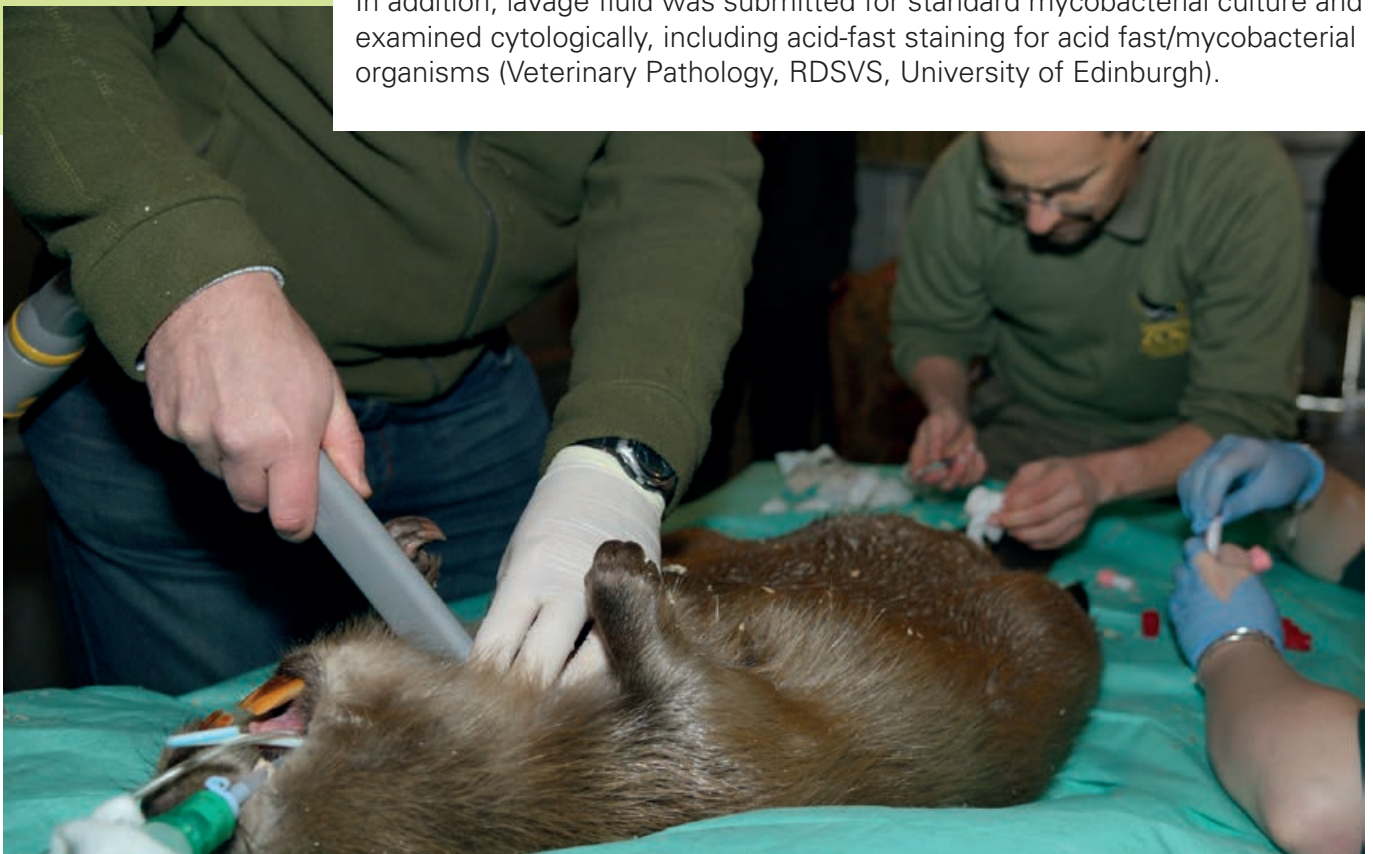
↓ Whilst beavers were anaesthetised, they were sampled by local Coleopterist (beetle specialist) Clive Turner looking for evidence of the host-specific parasitic beaver beetle *Platypsyllus castoris*. No evidence was found.

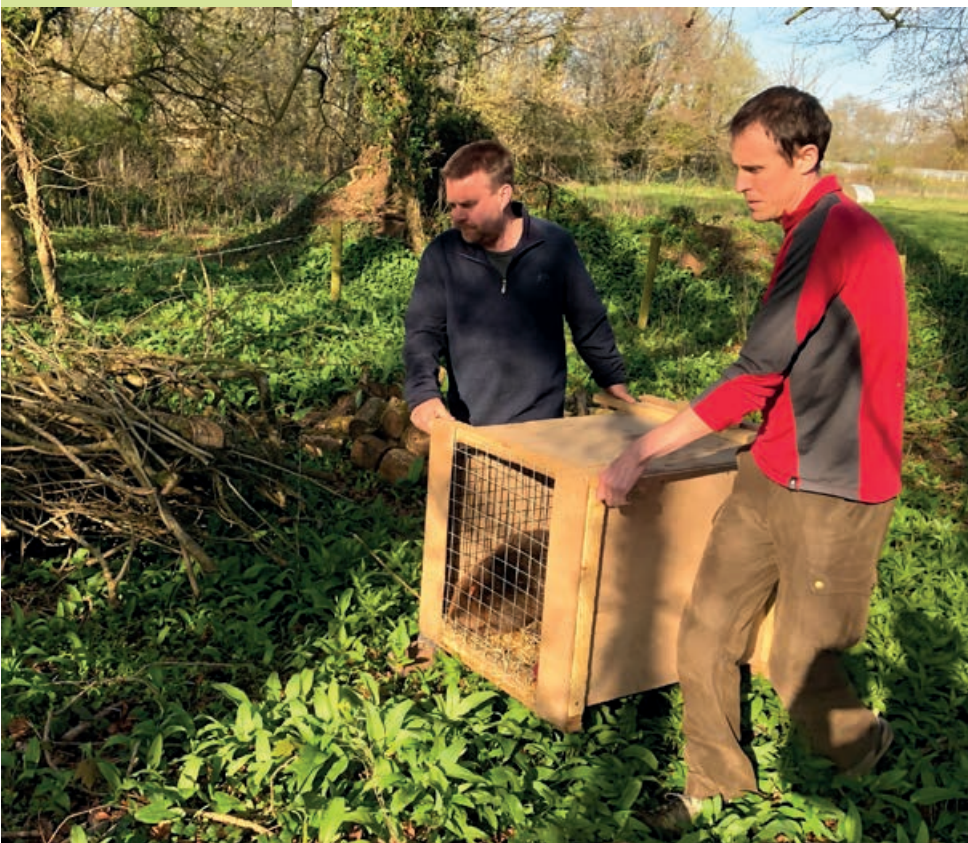
↓ Beavers are transported to the release location in a carrying crate.

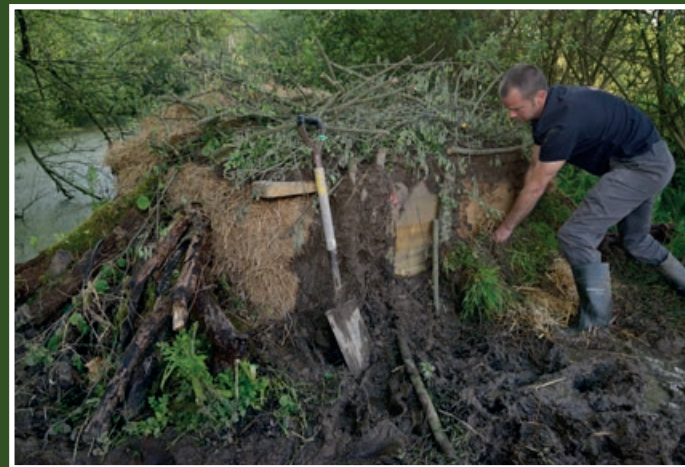
↑ Providing some shelter such as an artificial lodge may help animals settle into the release location. Animals can either be released into the lodge, or nearby, and moving their bedding from the holding facility or carrying crate is sometimes used as a technique to encourage settlement.

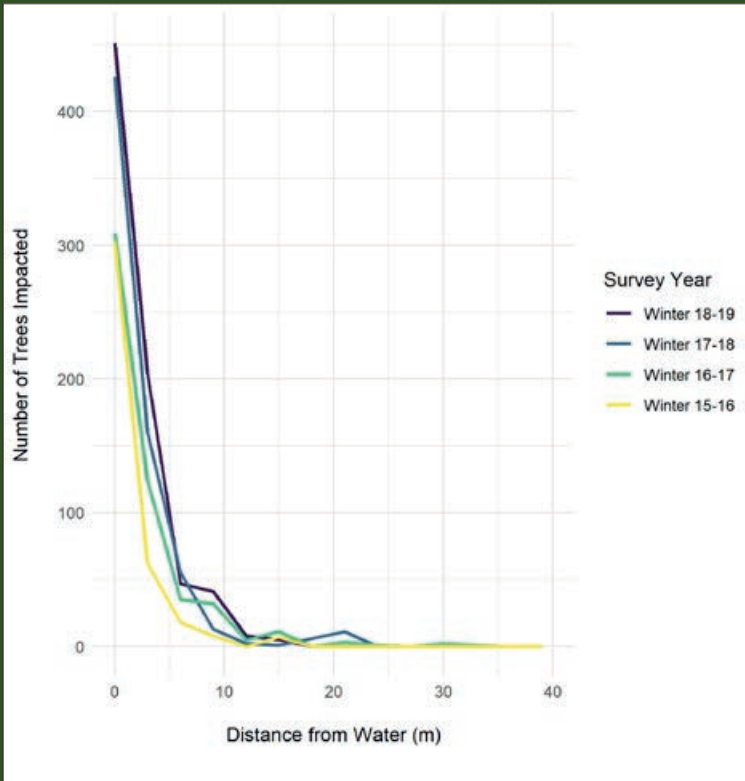
↑ **Figure 5.1** Winter browsing on woody species is mostly on trees close to the water's edge. Here those trees that are fed on from within the water are included in the figure for 0m.

Survey work carried out during the Trial shows that 99.8% of feeding signs are detected within 30 m of the banks of watercourses (see figure 5.1).

The annual systematic surveys of the catchment have provided a dataset of 2,356 trees that have been fed on since the first surveys were conducted in 2015. These clearly show how the majority of feeding is very close to, or within water (Figure 5.1) and that winter browsing in the River Otter catchment is predominantly on willow, although a wide variety of species are occasionally used (Figure 5.2).

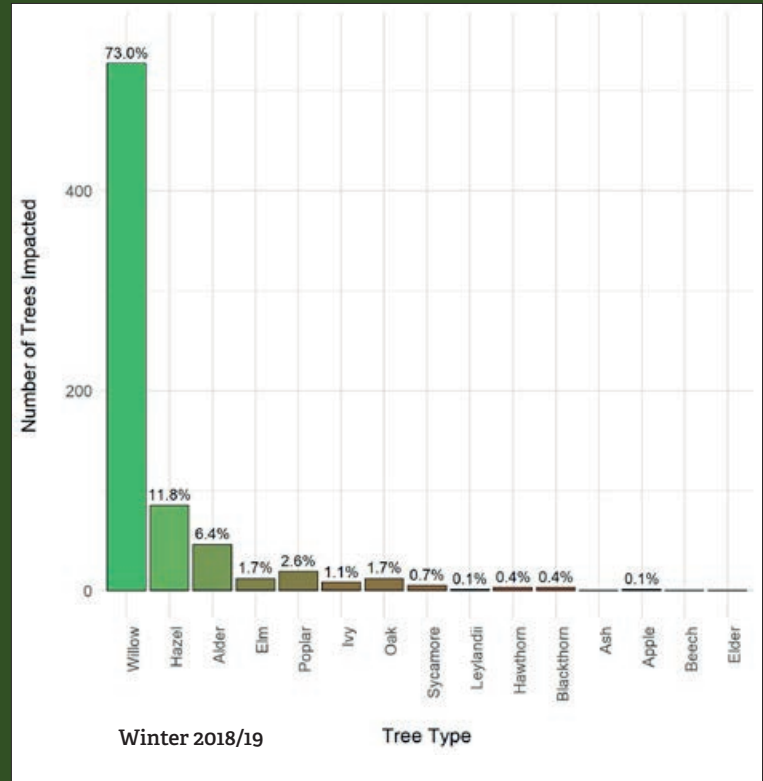
↑ **Figure 5.2** Tree species impacted by beaver activity surveyed in winter 2018-19 showing the importance of willow browsing to the beavers in the River Otter catchment.

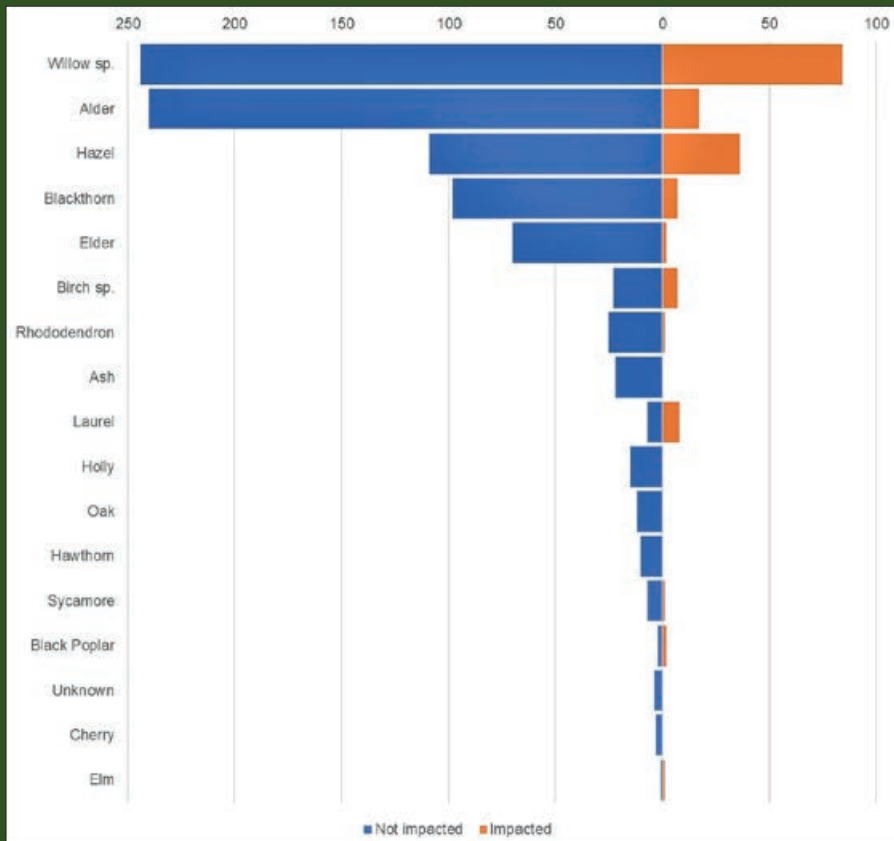
↑ **Figure 5.3** In early 2019 a survey was undertaken to assess whether selection of winter foraging was related to the proportion of tree species found within four of the beaver territories. This indicated an overwhelming preference for willow. Data collected by Fiona Coope.

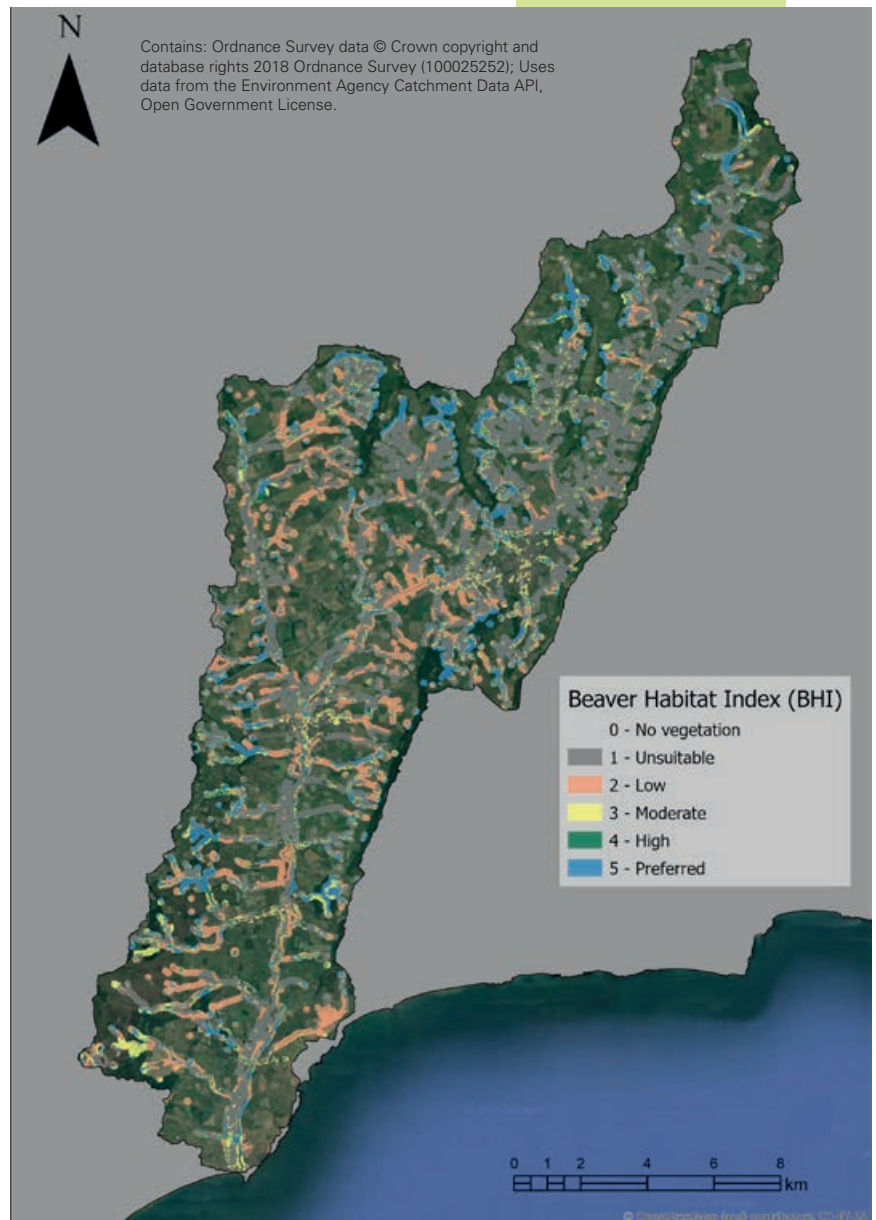
↓ **Figure 5.4** Beaver Habitat Index for River Otter catchment

The BHI provides crucial information for community and stakeholder engagement, pre-emptive management of beaver impacts, release site identification, the prediction of viable territories, dam capacity and likelihood of dam construction.

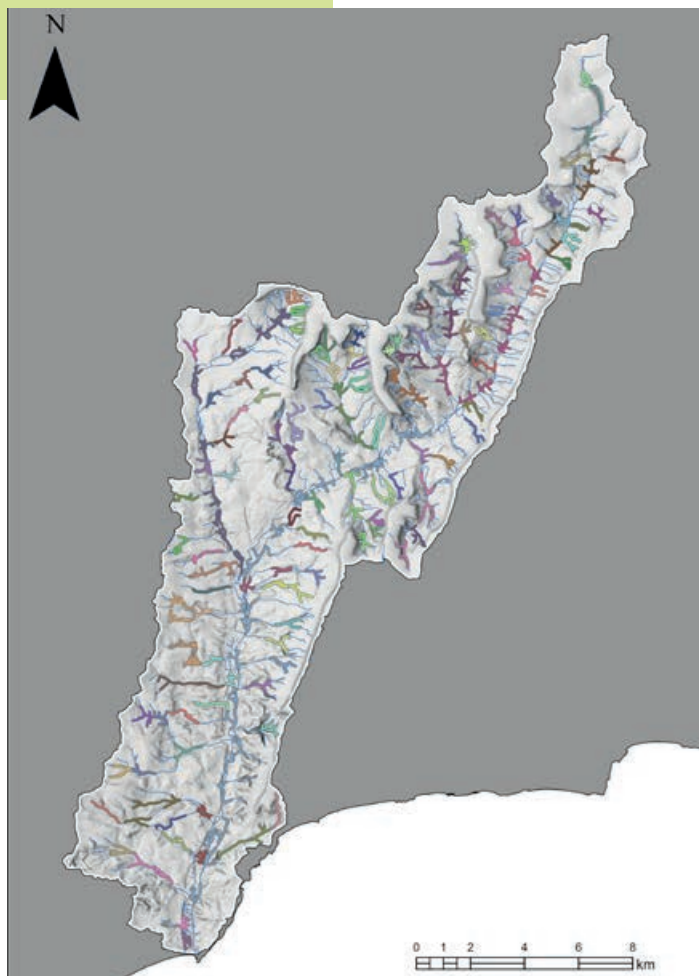
Figure 5.6 The maximum number of territories, shown as unique colour zones along the stream network, that the TCM predicts is between 147 and 179. This area of research requires further validation and should be a key area of focus for future research as populations expand.

The purpose of the model is not to predict the location of territories, rather to determine the maximum number of territories which could occupy a catchment. Beavers are unlikely to conform to the modelled arrangement of territories which would therefore limit the maximum number that fit in a catchment. Additionally, the model assumes that animals cannot exit the catchment. These assumptions mean that the predicted territory capacity derived from this model should be considered as an absolute maximum and we would expect the observed capacity (if this were allowed to be reached) to be considerably lower.

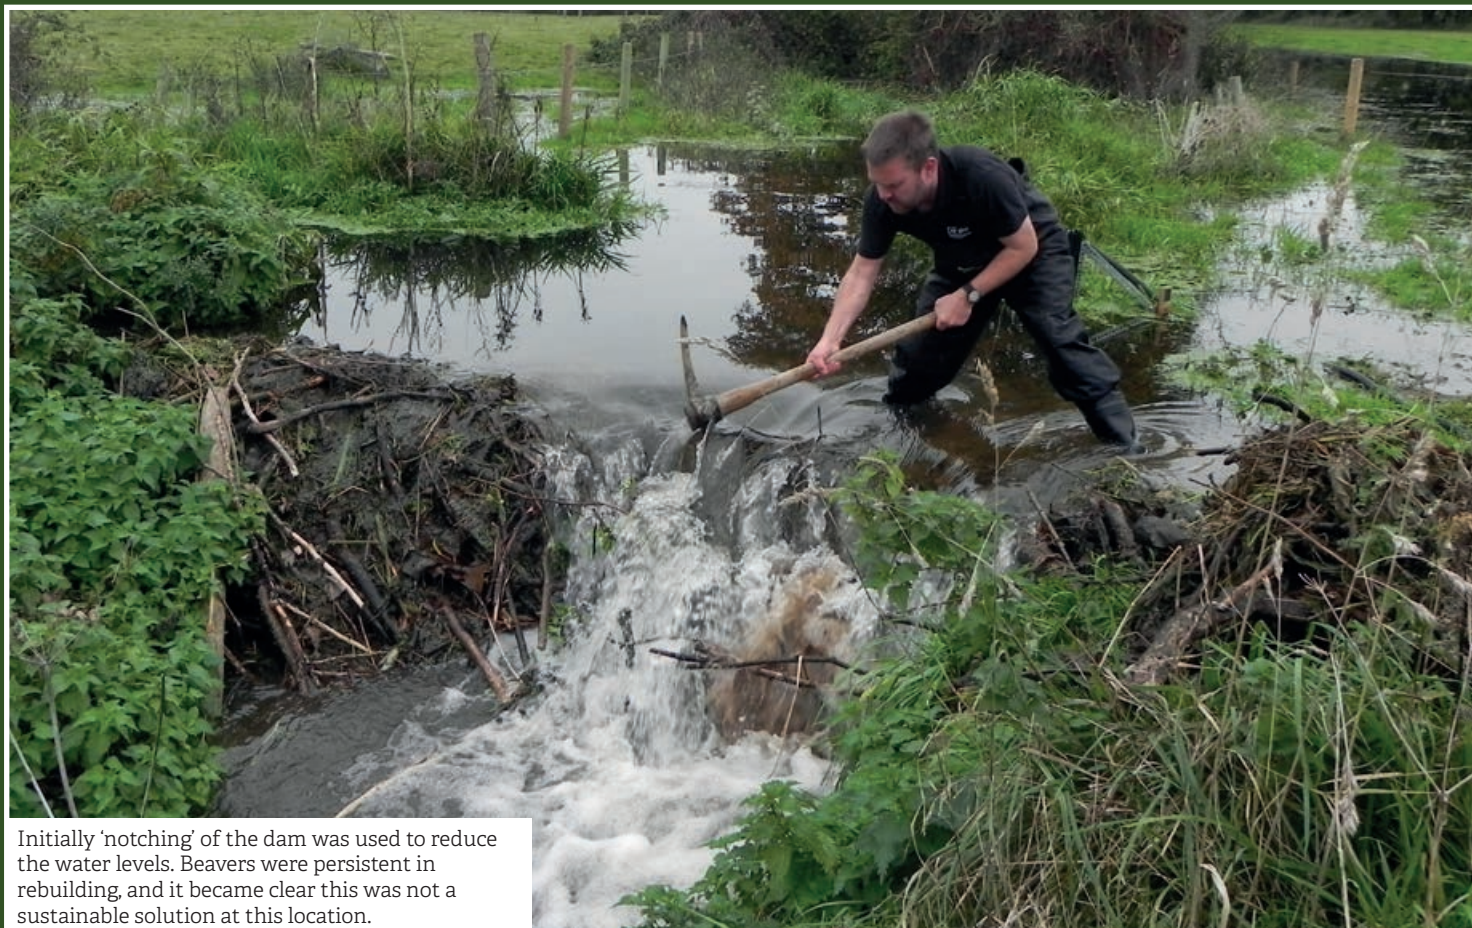
Initially 'notching' of the dam was used to reduce the water levels. Beavers were persistent in rebuilding, and it became clear this was not a sustainable solution at this location.

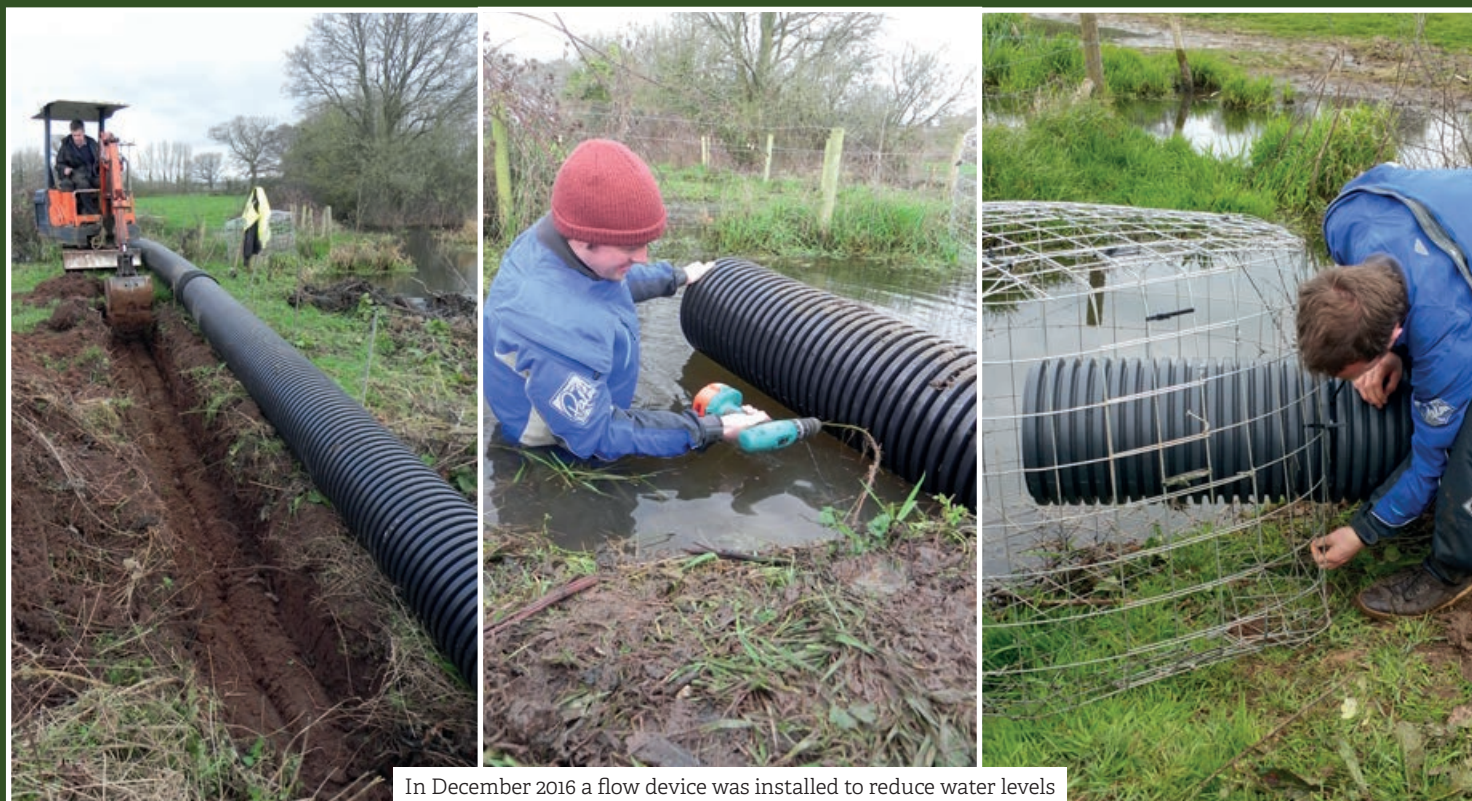
In December 2016 a flow device was installed to reduce water levels

- This intervention is used to reduce water height behind beaver dams whilst maintaining beaver presence.
- The structure comprises a pipe that allows water to bypass or flow through the beaver dam. The pipe inflow is situated in a submerged cage to prevent beavers detecting the source of the leak and blocking the pipe.
- This flow device was installed at a cost of £500. Due to the design and location of this device, consent from Local Authority was not required.

When the device was installed, the water levels dropped significantly, reducing the extent of flooding in the adjacent fields.

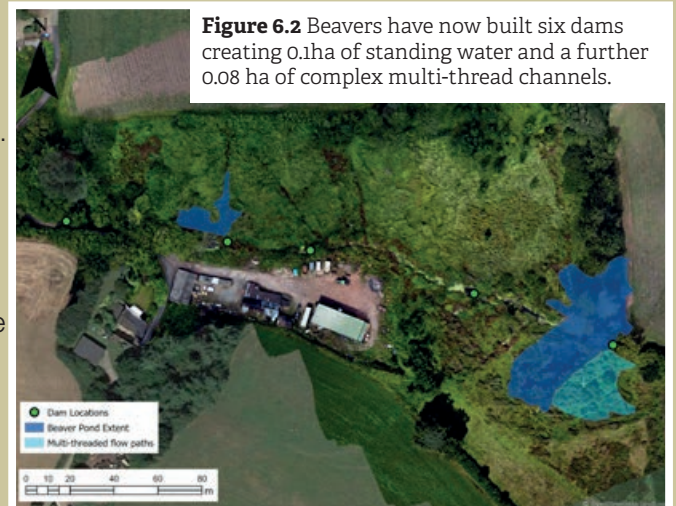
Figure 6.2 Beavers have now built six dams creating 0.1ha of standing water and a further 0.08 ha of complex multi-thread channels.

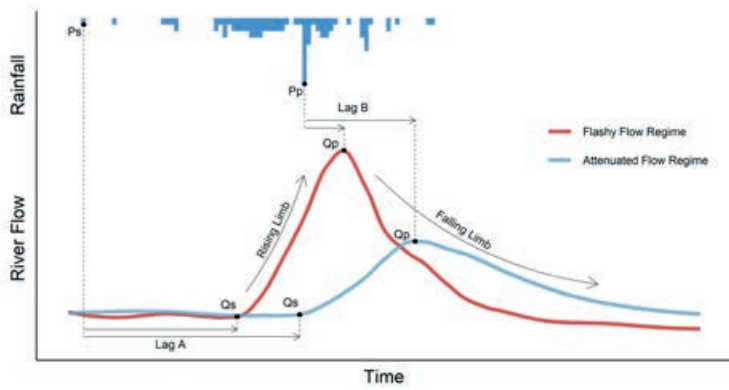
Figure 6.3
A schematic hydrograph showing the different elements of an attenuated flood hydrograph.

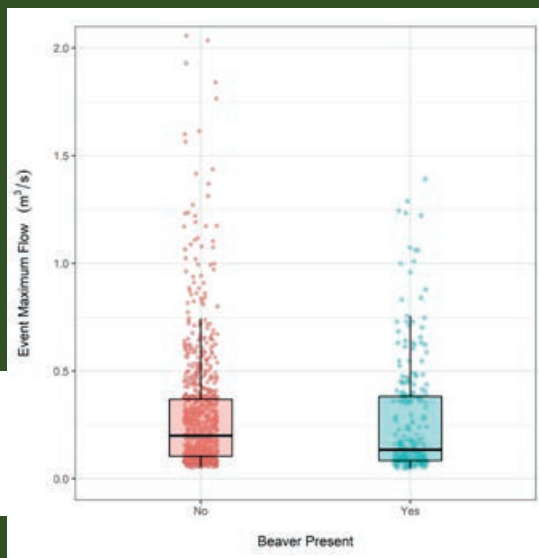
Figure 6.5 Peak flows before (red) and after (blue) beavers impacted the hydrology.

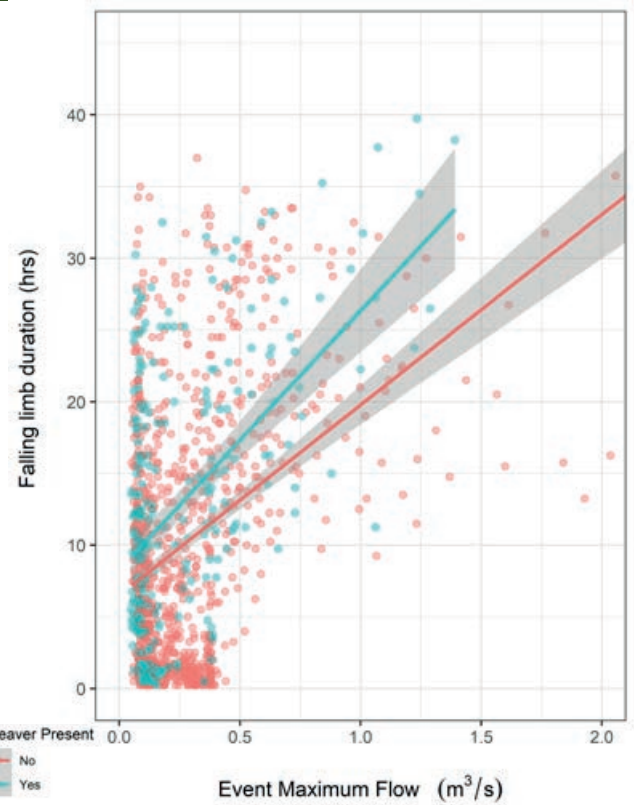
Figure 6.6 Relationship between maximum flow and the time taken for flows to return to a normal (base) flow for hydrological events before (red) and after (blue) beaver dams were constructed. After beavers constructed dams, the time taken for river flows to fall from their peak to base flow was, on average, greater than before dams were constructed. This indicates that water is being released from the beaver ponds more slowly, attenuating downstream flow.

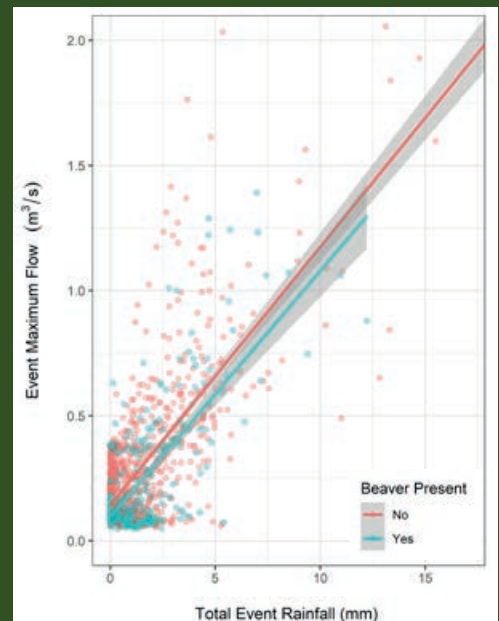
Figure 6.4 Relationship between total rainfall and maximum flow for hydrological events before (red) and after (blue) beaver dams were constructed. After beavers constructed dams, downstream flows were more likely to be lower for a given amount of rainfall.

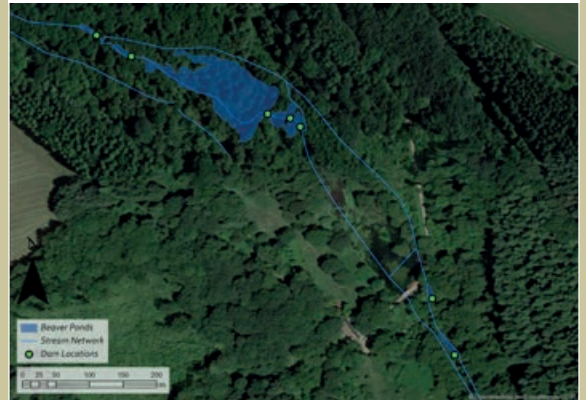
Extent of open water created by beavers as a result of damming upstream of Otterhead Lakes.

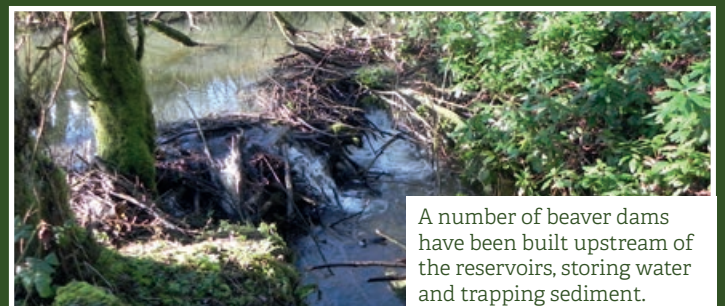
The beavers are living in an engineered lake with a dam and stepped spillway with a second discharge point via a wooden drop-board sluice and culvert. The activity of the beavers on these structures is carefully monitored and managed, to avoid issues with water management.

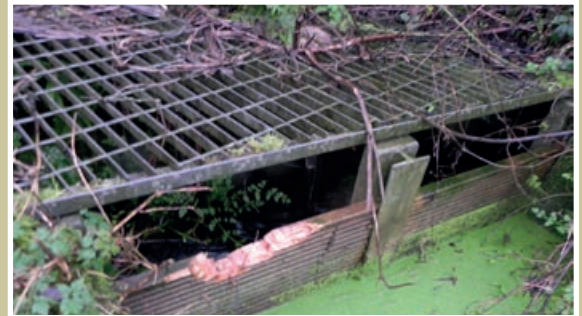
The crest of a spillway within a culvert has been the focus of damming activity by beavers. The ROBT was supported by local volunteers who inspect and remove the build-up of beaver sticks.

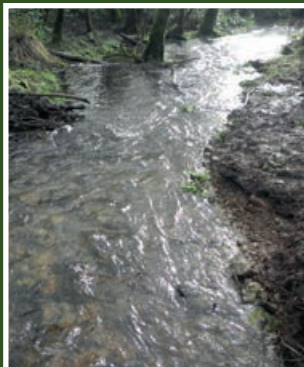
The sound of flowing water is one of the triggers for beavers to build dams and raise water levels. The two outflow points from the reservoir attracted the attention of the beavers. Initially the wooden dropboards were chewed and sticks were used by beavers in an attempt to stop flows at this point. This was not a recurrent issue however.

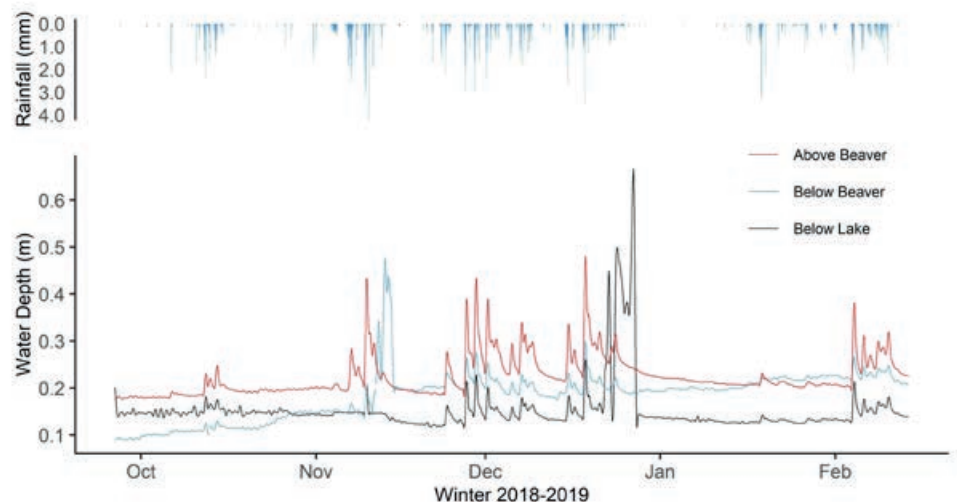
Time series data illustrate the fast response times of flow into the site, above the beaver dams and upper reservoir. Monitoring will continue to quantify whether beaver dams attenuate flow through this drinking water reservoir system and also to establish what level of sediment retention beaver dams may (or may not) deliver. Reducing sediment loading on drinking water reservoirs is a priority, and in this example is also desirable to reduce siltation of the reservoir which is stocked by a local fishing syndicate with brown trout.

Figure 6.8 An early example of the continuous hydrological (channel depth) data being collected. Monitoring began in September 2018.

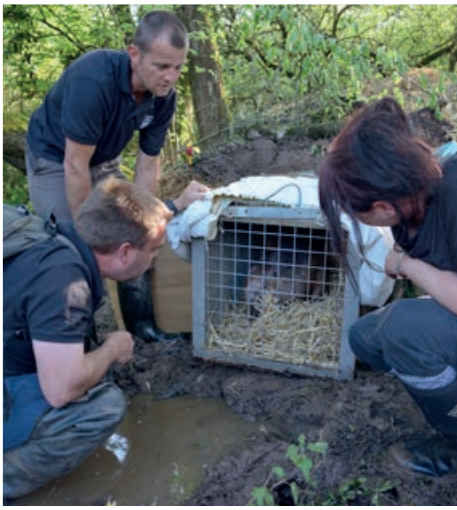
Two artificial lodges were constructed on the edge of the large pond, providing refuge and helping the animals to settle into the release location. The pair of beavers were released separately into the lodges. Transferring their bedding from the holding facility or carrying crate was used as a technique to provide the animals with a familiar scent enabling them to accept their new surroundings. Photos: Nick Upton

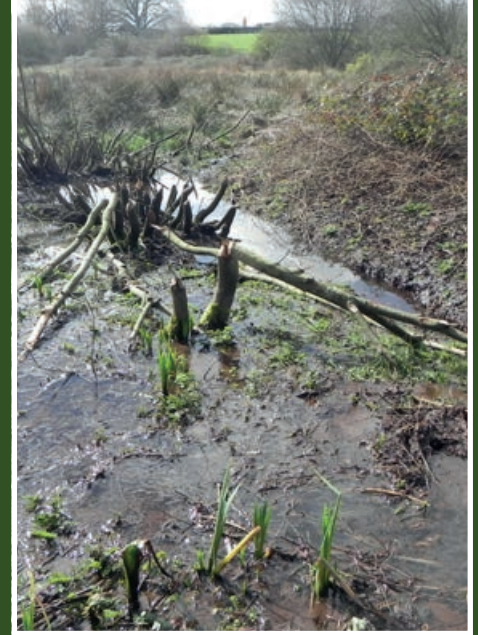
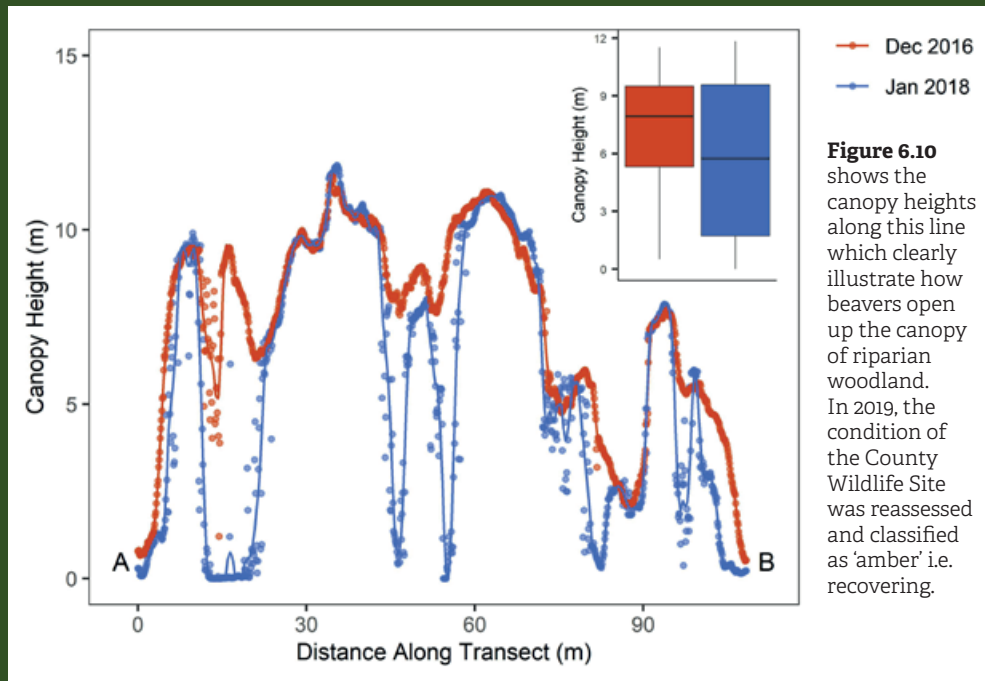
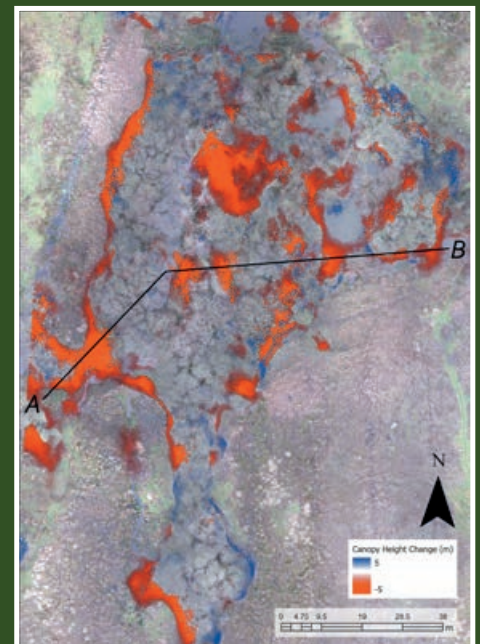
It was anticipated that some trees would be felled/coppiced, and under-storey vegetation would respond. Drone photogrammetry and spatial data analysis was used to capture and quantify changes to vegetation structure across the site, resulting from beaver activity. Winter feeding signs surveys recorded that 209 trees were impacted. Photogrammetry has shown beavers have strongly influenced woody vegetation structure - a reduction in canopy heights and an increase in canopy variability, with a greater range of tree shapes/sizes than before beaver reintroduction.

Figure 6.9 Aerial image showing where areas of the canopy have increased in height or been reduced. Numerous areas of canopy have been lowered by beavers, which has increased light penetration and canopy height variability. The cross section indicated on the map, intersects a part of the canopy which has experienced extensive felling.
