River Otter Beaver Trial

Science and Evidence Report

The River Otter Beaver Trial is a 5-year trial reintroduction of Eurasian beavers, *Castor fiber*, into the wild in south east Devon. It began with two family groups of beavers in 2015 which have now bred and dispersed throughout the catchment. The Science and Evidence Forum have overseen a detailed research programme, the findings of which are summarised within this report.

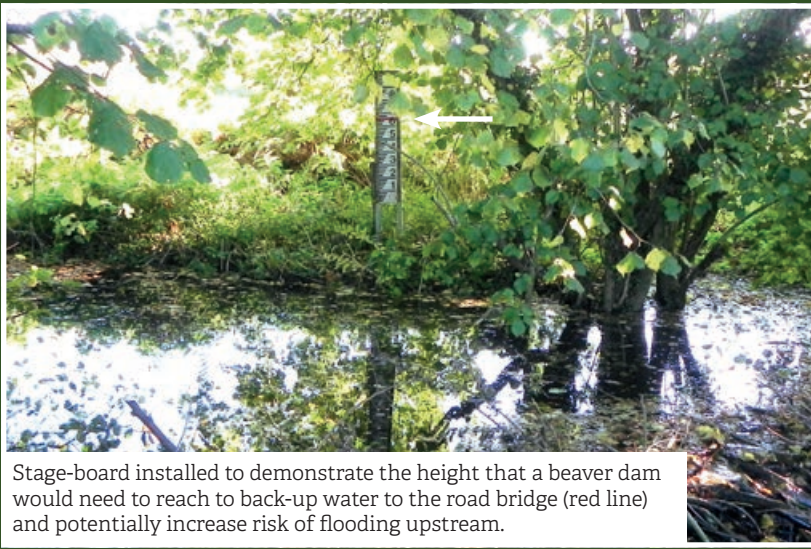
Stage-board installed to demonstrate the height that a beaver dam would need to reach to back-up water to the road bridge (red line) and potentially increase risk of flooding upstream.

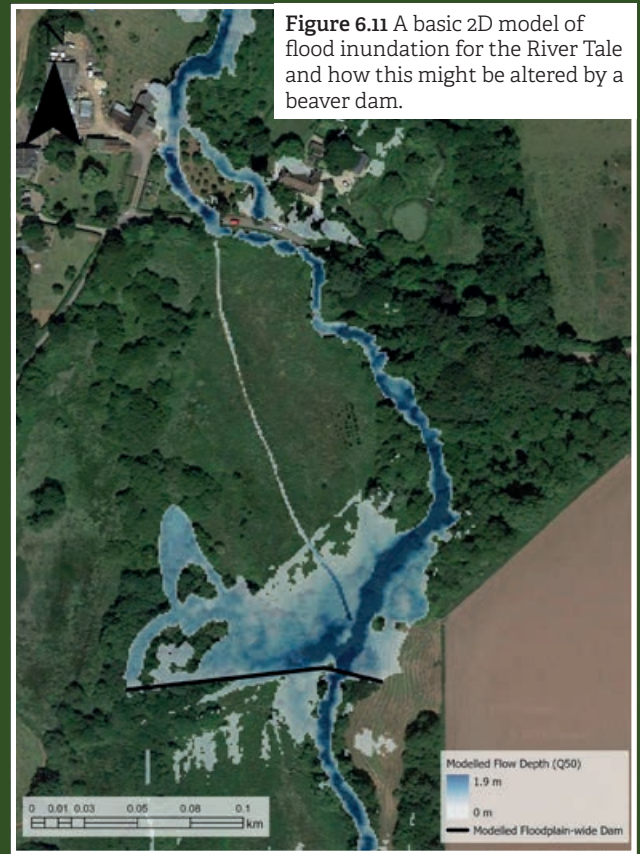
Figure 6.11 A basic 2D model of flood inundation for the River Tale and how this might be altered by a beaver dam.

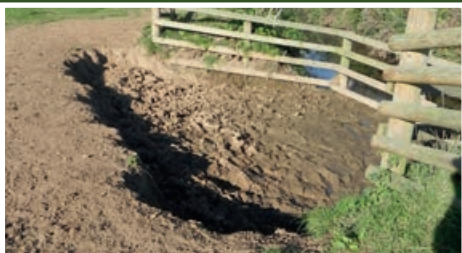
Impounded water caused silt to be deposited in a drinking bay that had been constructed to restrict cattle access to the river.
